**NATIONAL REGISTER OF HISTORIC PLACES
INVENTORY -- NOMINATION FORM**

Matthew Lynch House

120 Robinson Street

Providence

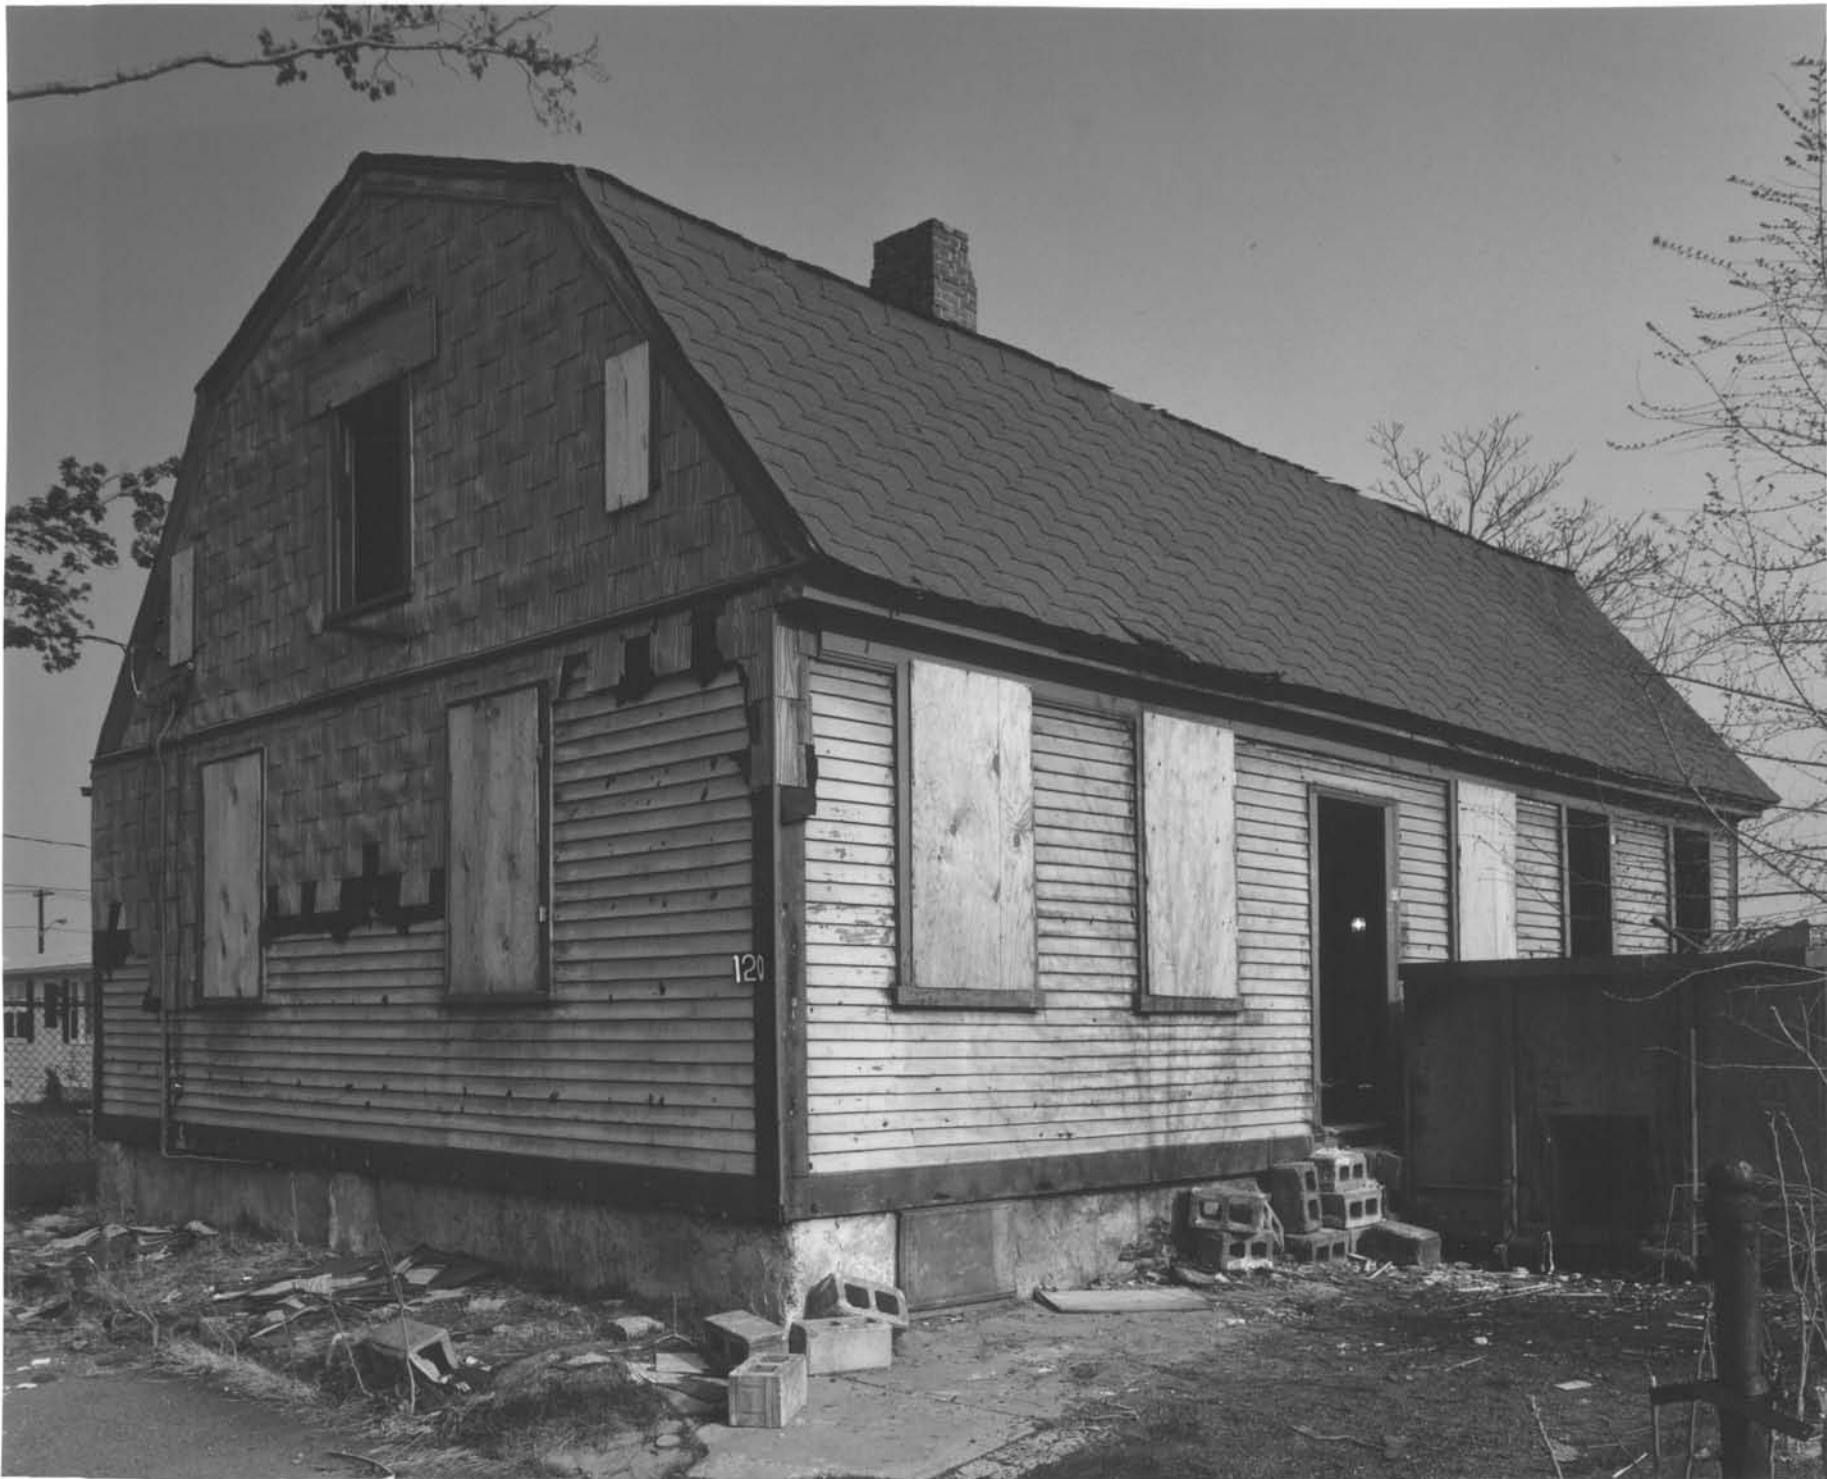
#1

House from the northwest.

Exterior trim is minimal and very simple. On the west entrance front the only embellishment is a simple fascia board with a surmounting eaves cornice which is carefully stopped, in profile, at each end just short of the corners of the house. Frugality, no doubt, accounts for the fact that there is no cornice on the rear of the building. Window openings on the front are placed directly beneath the fascia, and their plain board enframements and sills have no mouldings or other trim. The main doorway does, however, have a modest moulding or bevel at the outer edge of its frame. The exterior doors are not original. Some of the nineteenth century two-over-two-paned sash in the principal windows have been replaced with nine-over-nine-paned sash. On the back walls, two windows have been closed off within the past year (see Plan B) and a new window cut in beside an existing window to accommodate the new kitchen. The gambrel peak at the north end of the house has

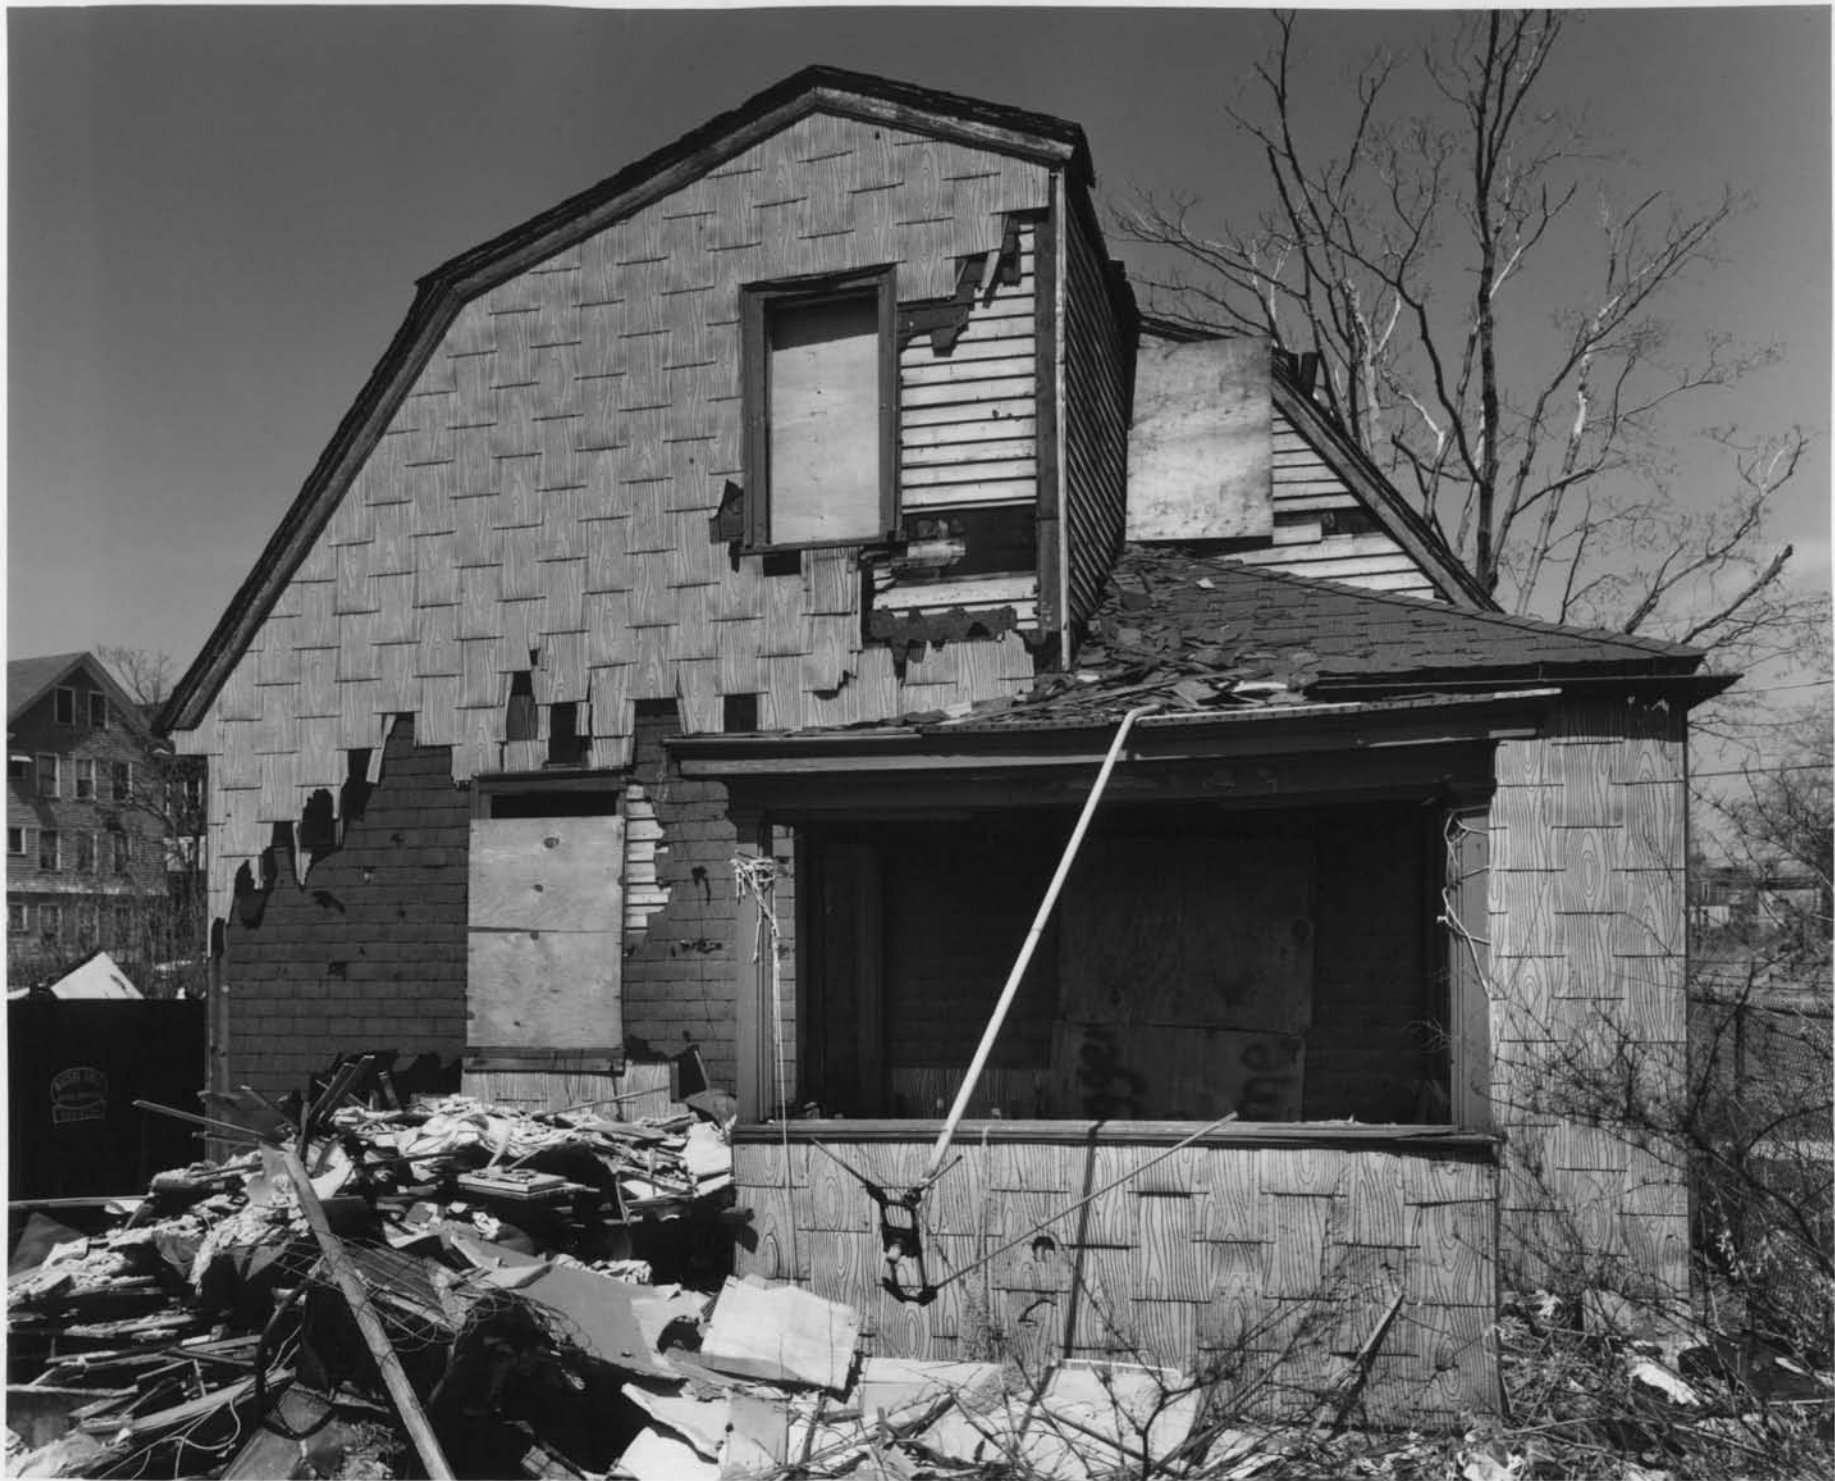
#2

House from the south, showing various additions.

As first built, the house was five bays wide and two bays deep, with the main entrance located in the center of the longer elevation. At some time, probably in the first quarter of the nineteenth century, the house was lengthened on what is now the south end by one bay. This extension did not, however, run back in full story-and-a-half height for the full depth of the house; rather, it created a three-quarters gambrel roofline at the rear, allowing the gambrel end window to remain open. The present owner, Stanford Cameron, has recently filled in this irregularity to make a standard gambrel roofline. In the 1920s or 1930s a small, low, hip-roofed, one-story addition (see Plan A) was pushed out from the southeast corner of the nineteenth century extension and an open porch attached there. Renovation currently being undertaken has already removed these early twentieth century alterations. Current work has also included stripping the dilapidated asphalt siding to reveal the wood clapboards beneath. Clapboards have been replaced as needed.

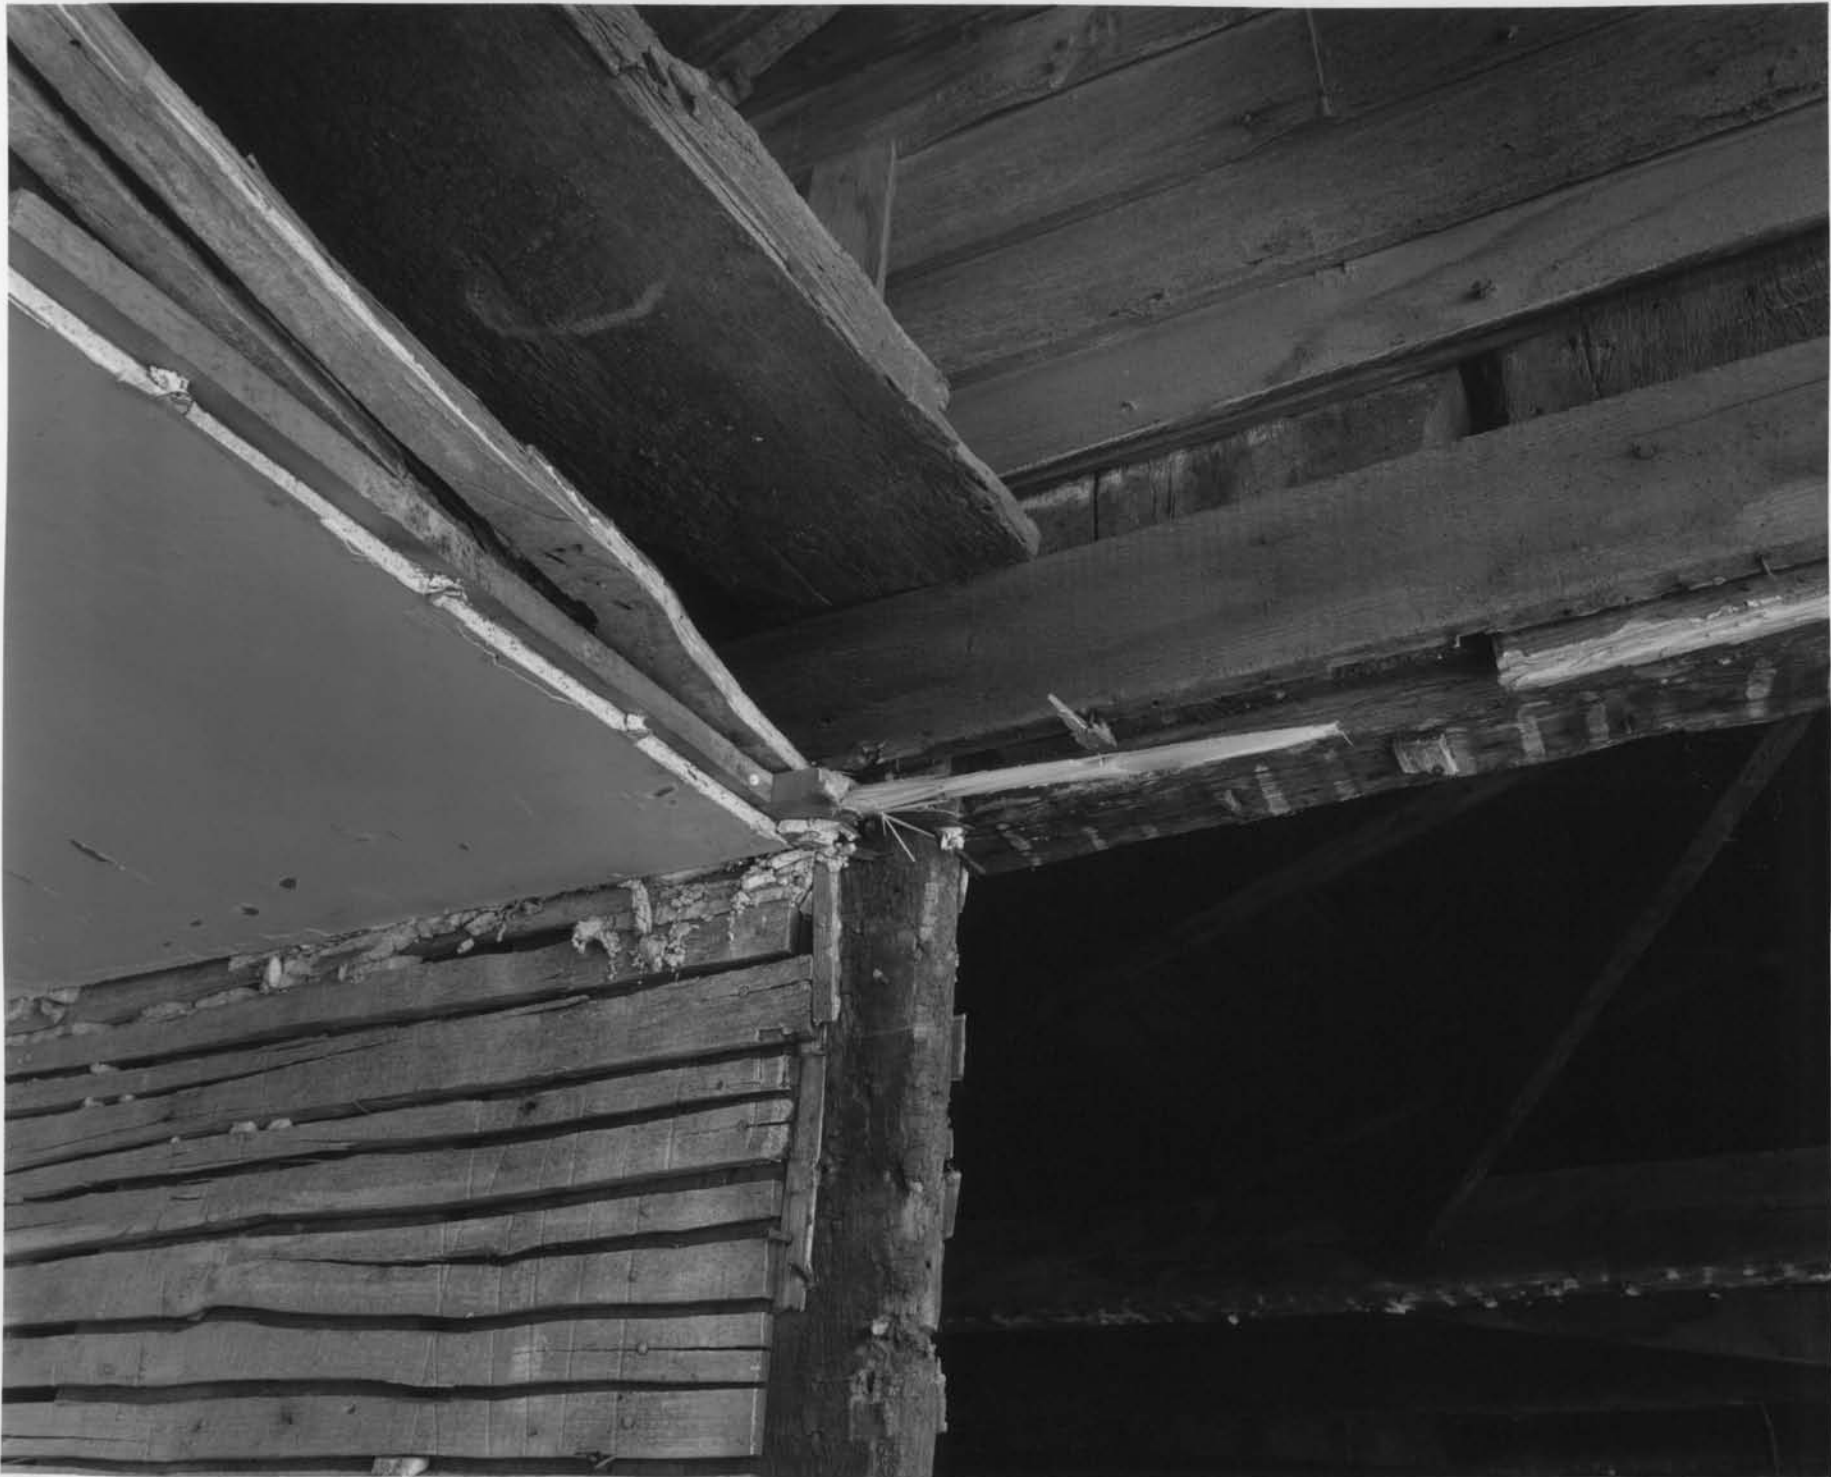
Detail of original south exterior wall, covered
by later half-gambrel addition and now by
completed gambrel.

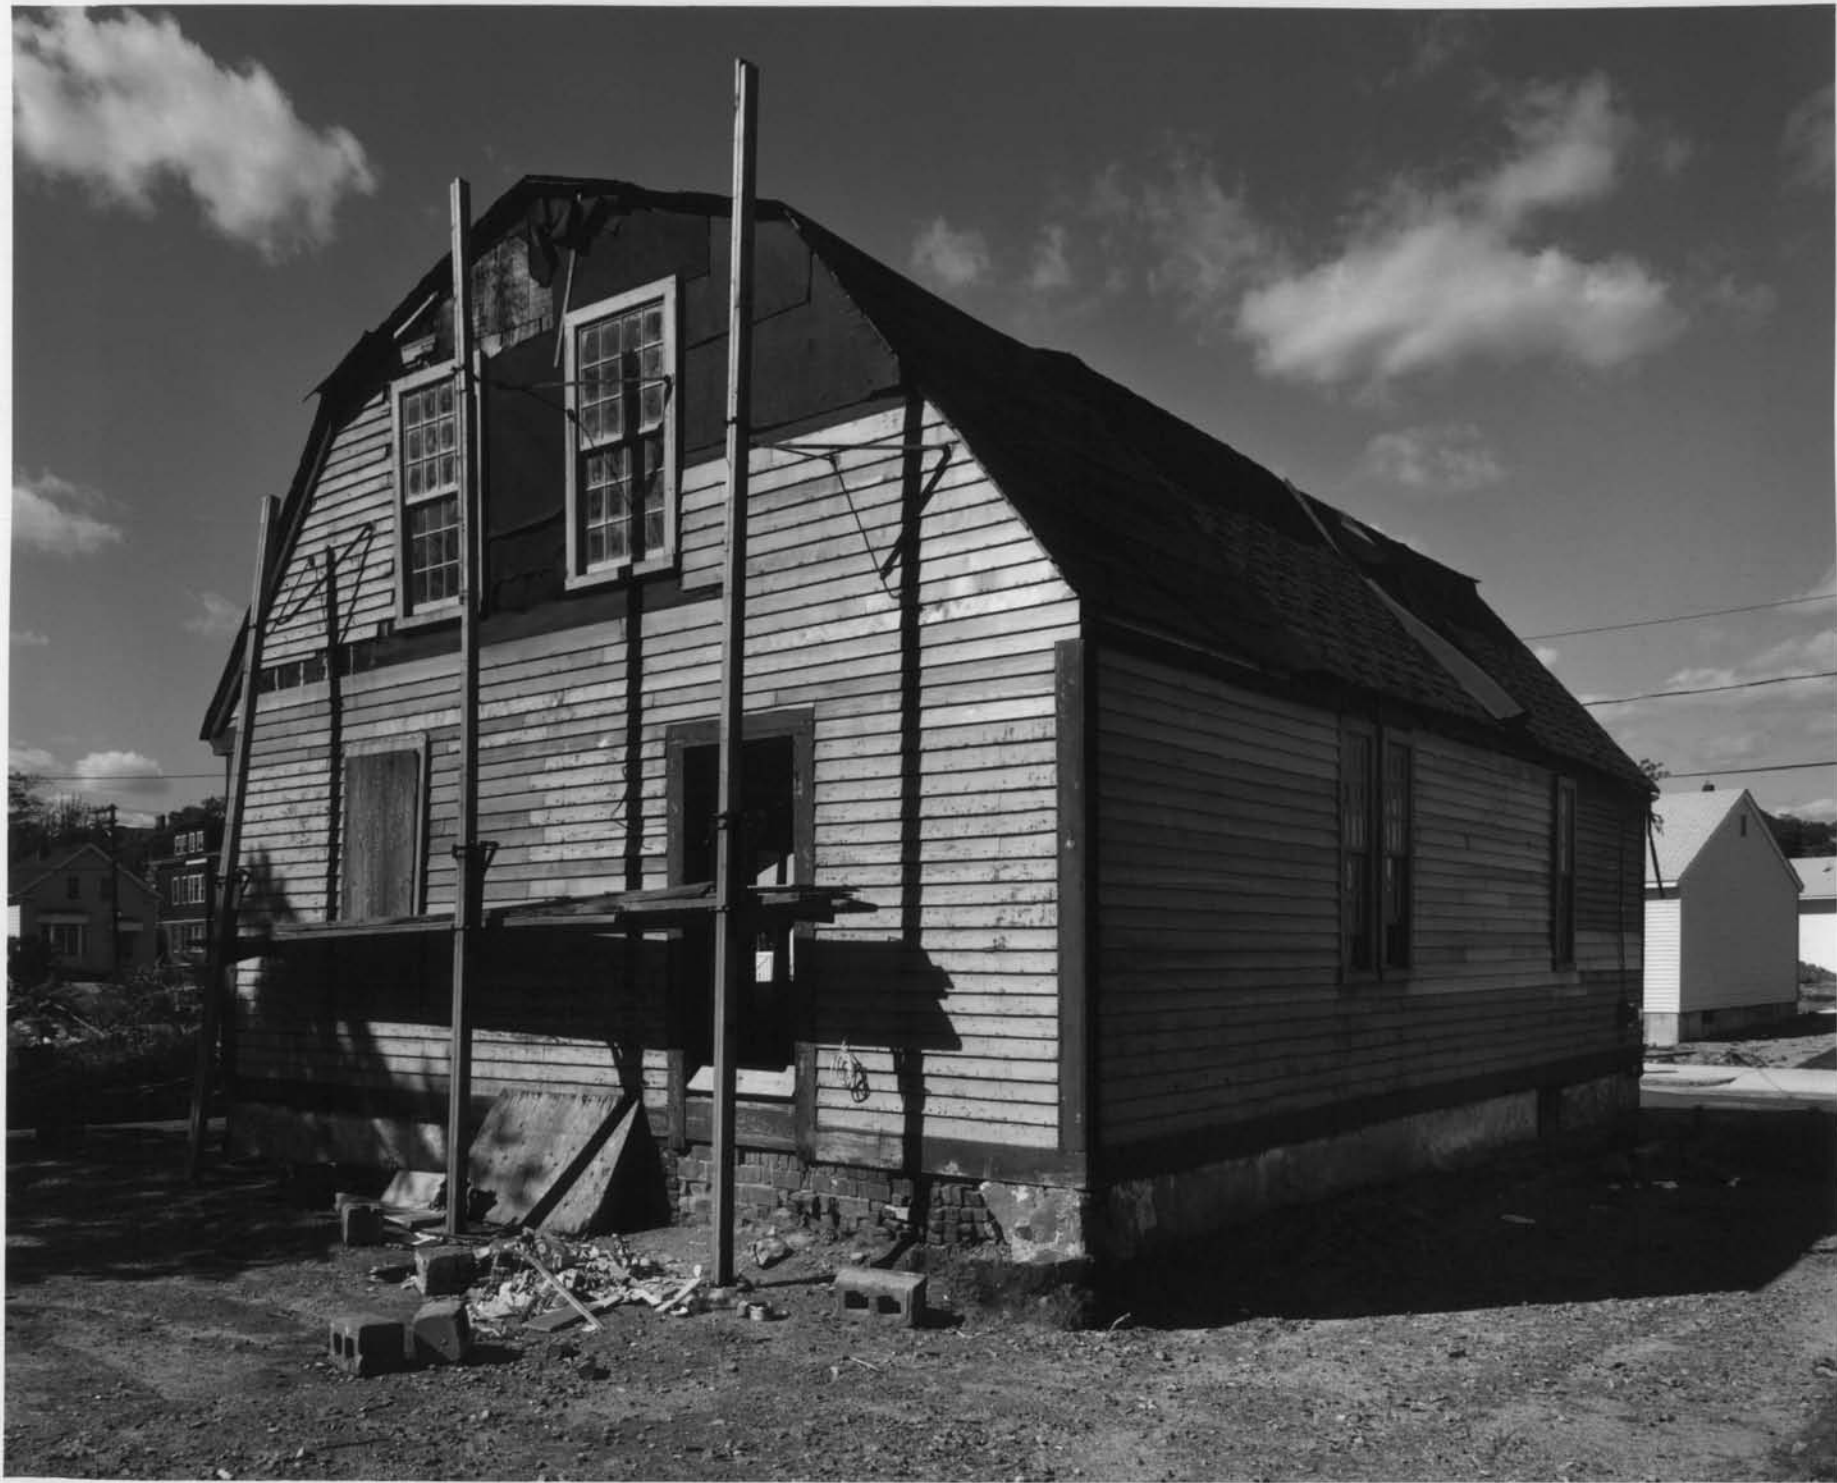
#4

House from the southeast.

Although the house was in generally dilapidated condition for a number of years and present renovation work has altered the interior plan, spatial arrangements, and detail, the exterior still reads as an eighteenth century house, despite window changes and the filling in of the southeast (rear) corner of the roofline.

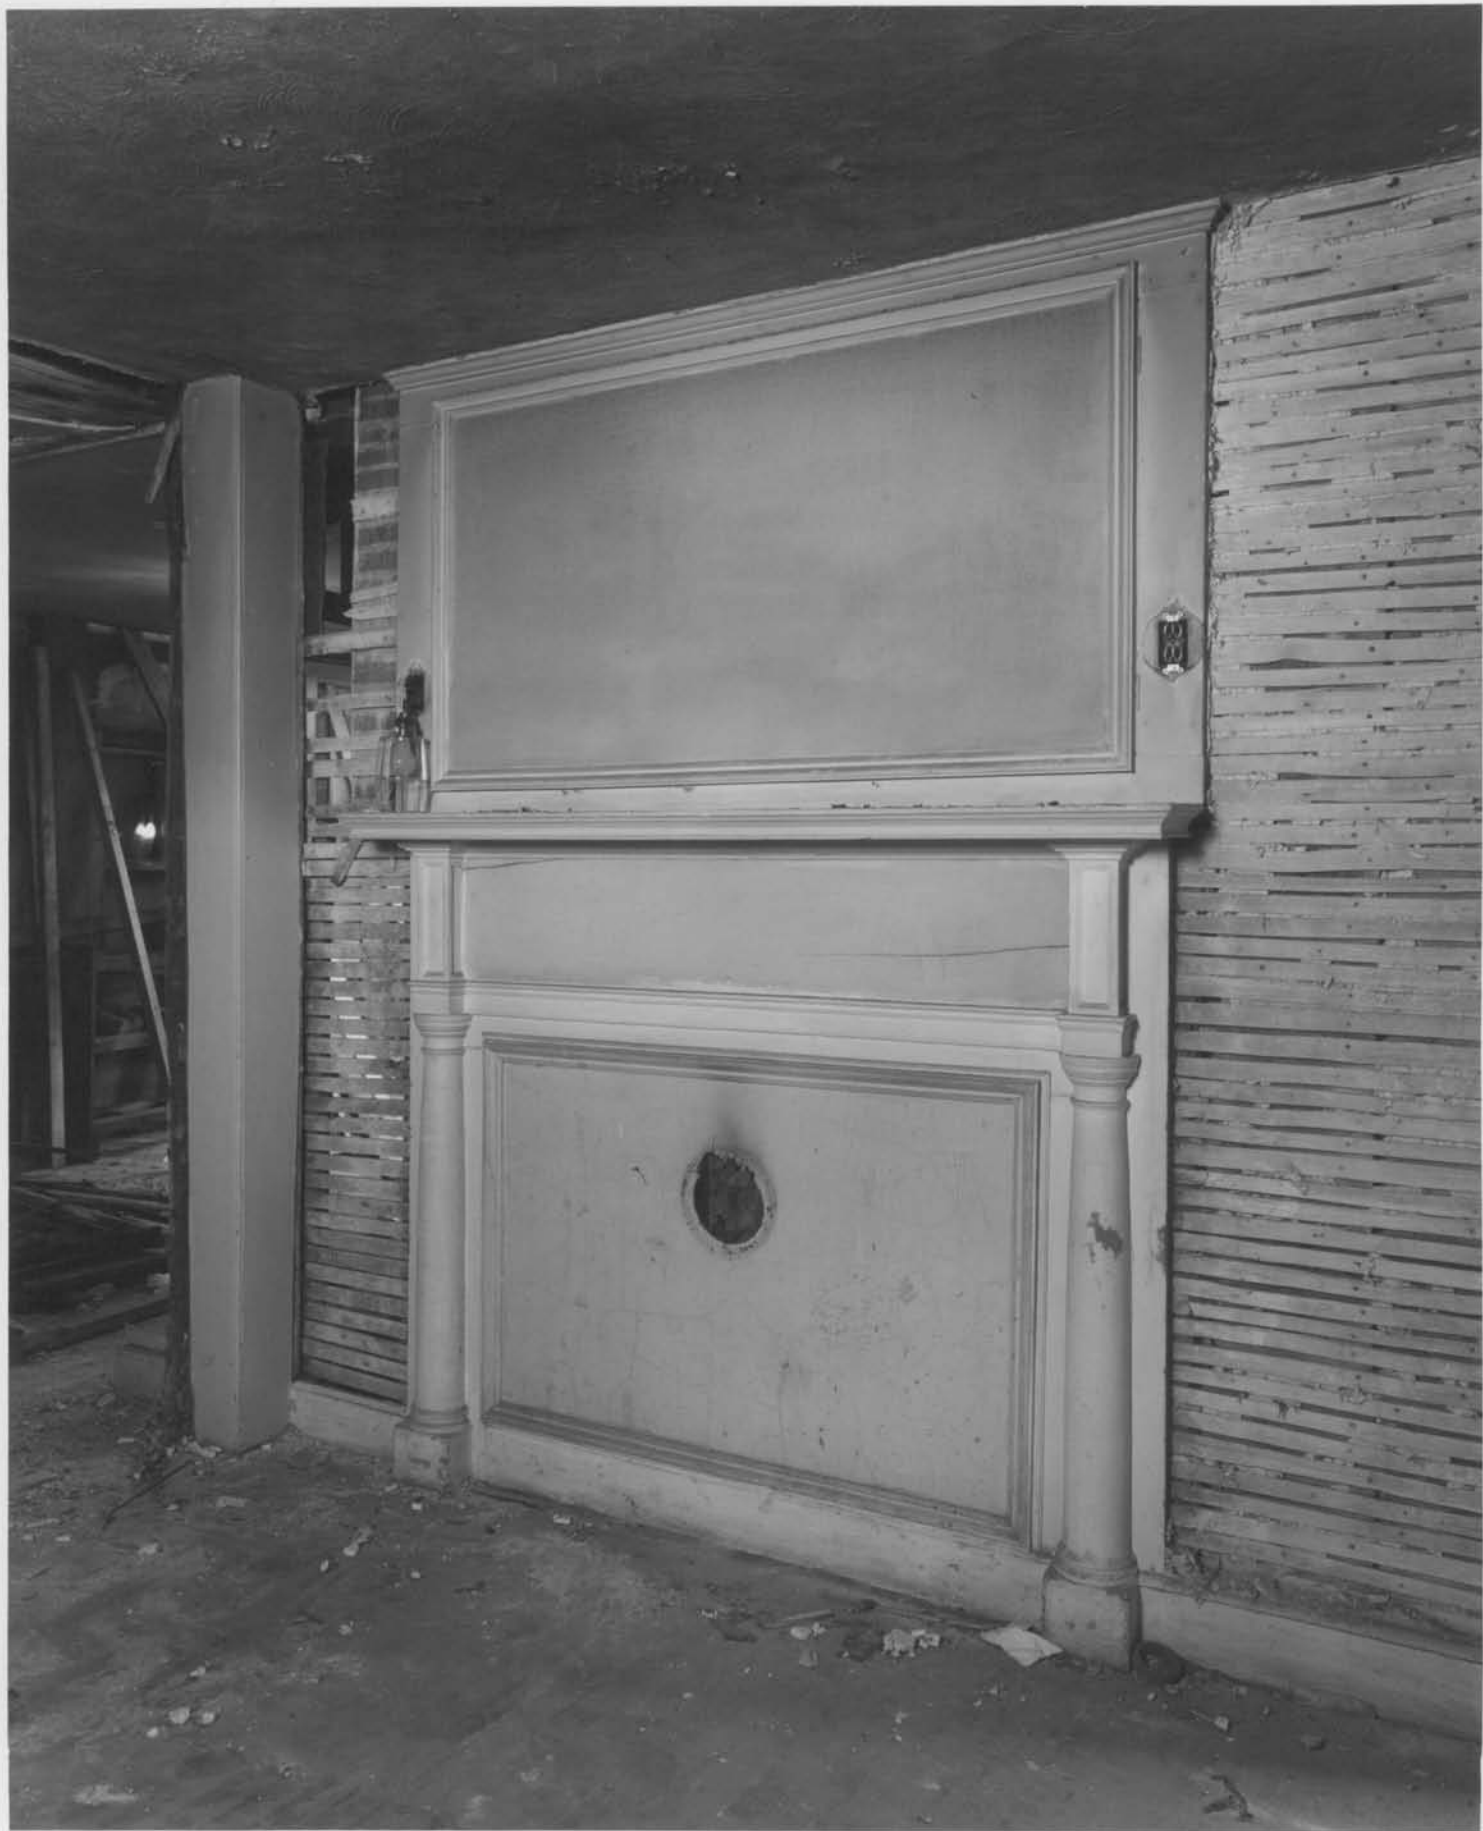
#5

Mantel in northwest parlor.

This was a handsome mantel with bolection surround and Federal style half-colonettes on low plinths at either side supporting a frieze and a shelf with crisply moulded edging, probably added when the house was enlarged in the early 1800s. Above the mantel was a horizontal raised wooden panel of mid-to-late-eighteenth century type. This mantel was disassembled and narrowed for use with the newly built fireplace in the living room area in 1977. Directly above the parlor, in the principal second floor bedroom, the moulding trim of another fireplace surround survived the 1865 move. The current work has covered or removed this trim as well.
