National Register of Historic Places  
Registration Form

historic name Sheldon House  
other names/site number \_\_\_\_\_

street & number 458 Scituate Avenue n/a not for publication  
city, town Cranston n/a vicinity  
state Rhode Island code RI county Providence code 007 zip code 02920

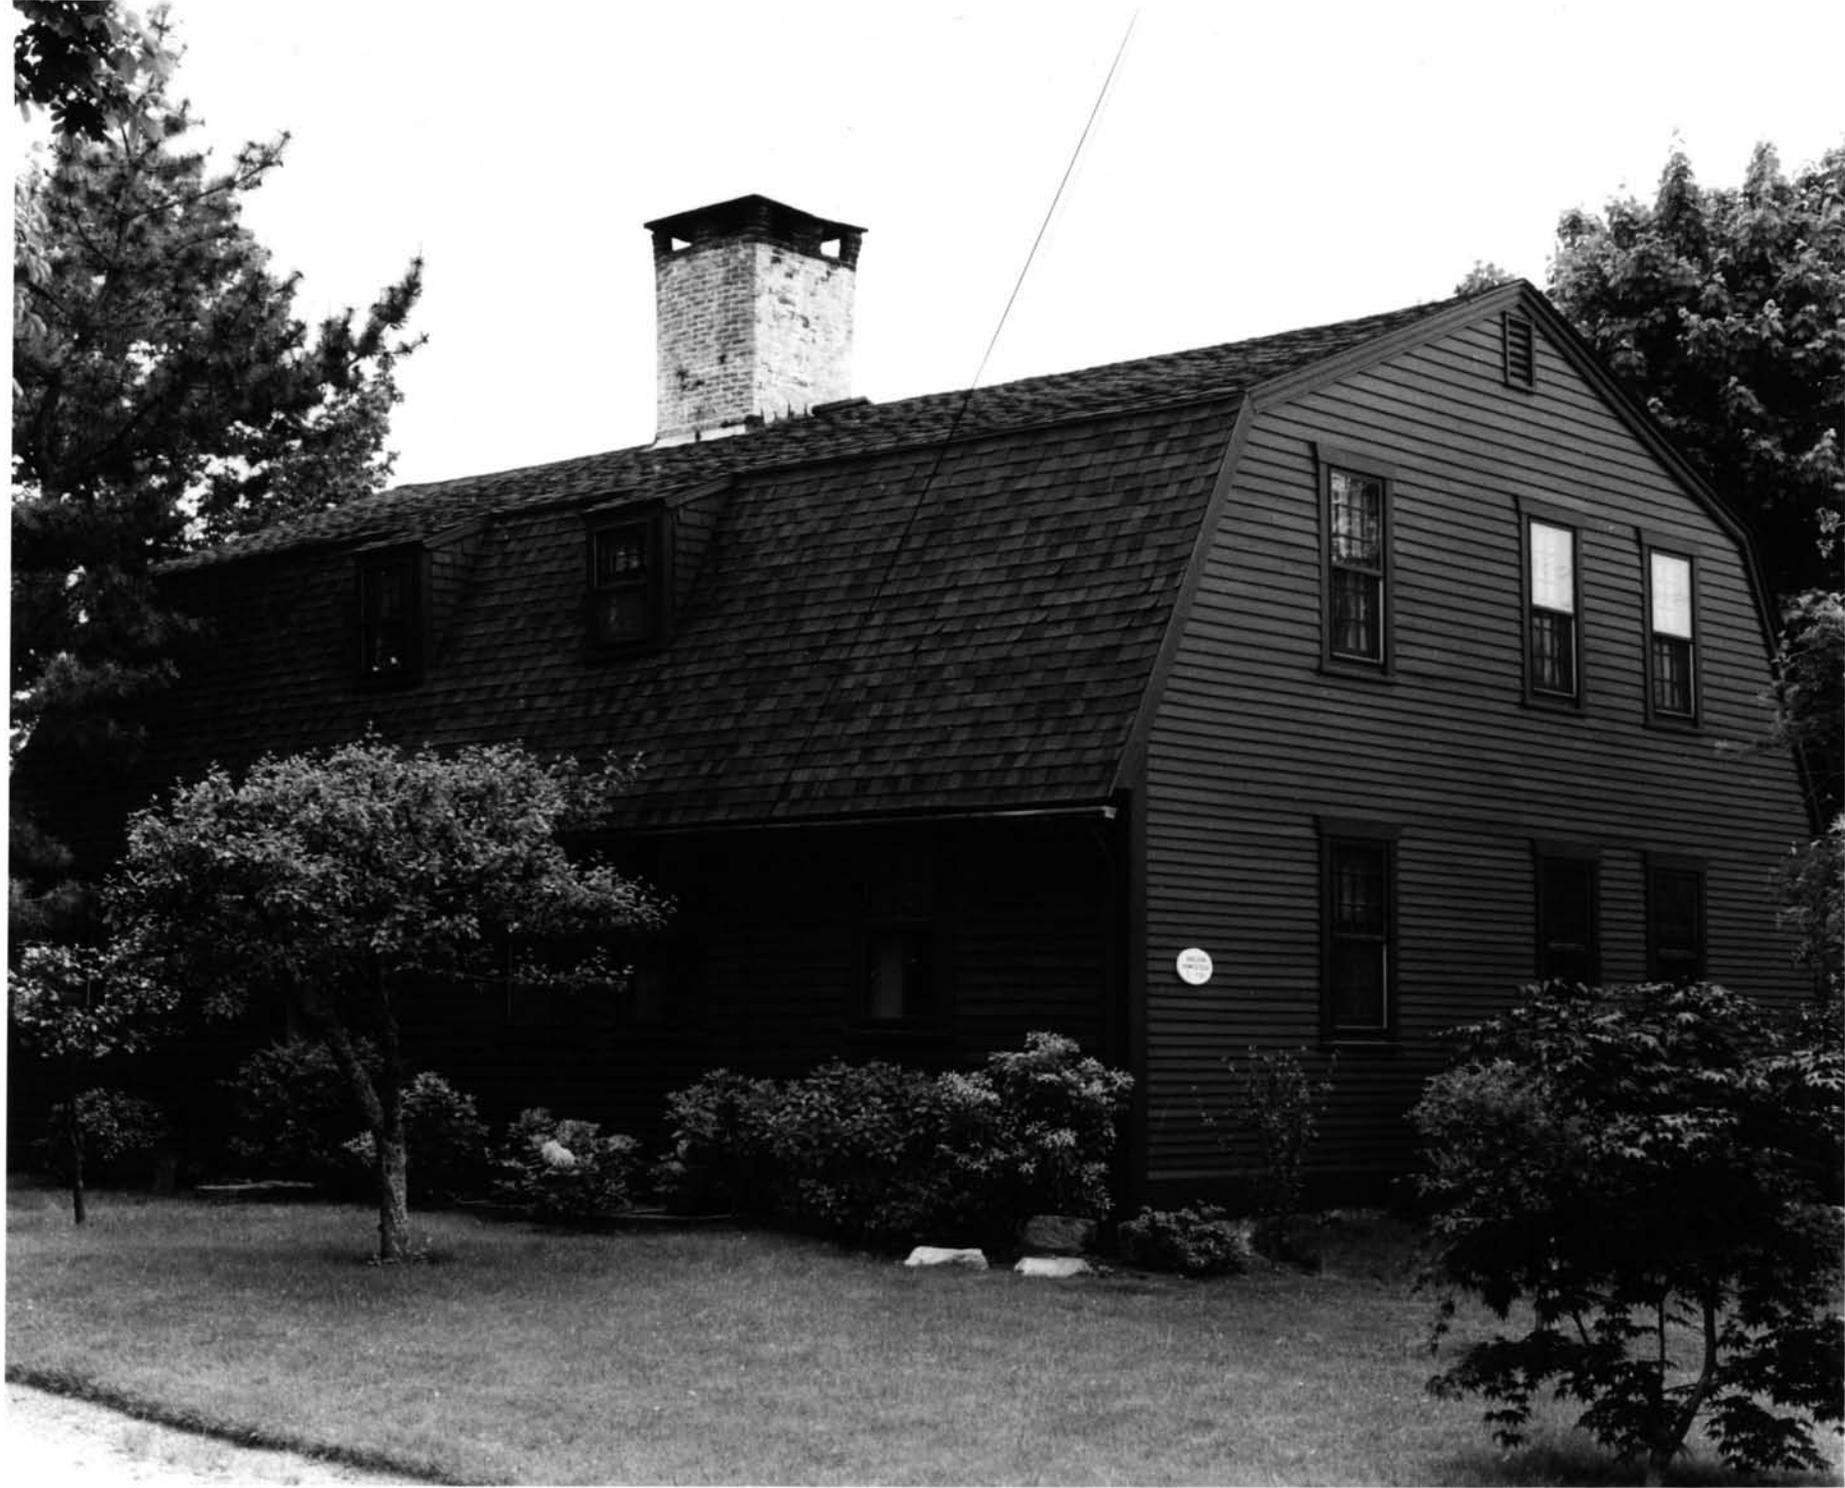
Photo #1

View: Exterior, northeast corner, showing east (front)  
and north (side elevations).

The Sheldon House is a clapboarded, one-and-a-half-story, four-bay, gambrel-roofed house with a brick center chimney. Built c. 1728, this is the oldest and largest of four one-and-a-half-story gambrel-roofed houses standing along the southern side of Scituate Avenue west of its intersection with Phenix Avenue. The house is set back perpendicular to the road and faces east. South of the house stand a well-head and a horse barn. To the east of the house is the 1804 Sheldon House (not included in this nomination) and to the west are acres of uncultivated fields and overgrown apple and walnut orchards that were once part of a large farm centered around these structures. The family burial ground (Cranston Historical Cemetery #19) is now part of an adjacent house lot to the west.

Two small dormers are set in roof on the front. The windows have mostly eight-over-eight and twelve-over-twelve sash. The window enframements on the north side display vernacular splayed window caps. The simple plank door with two-light transom is set asymmetrically in the facade, which arrangement may indicate that the Sheldon House began as a half-house. A summer kitchen, probably early-to-mid-eighteenth century, is attached to the southern end of the main house.

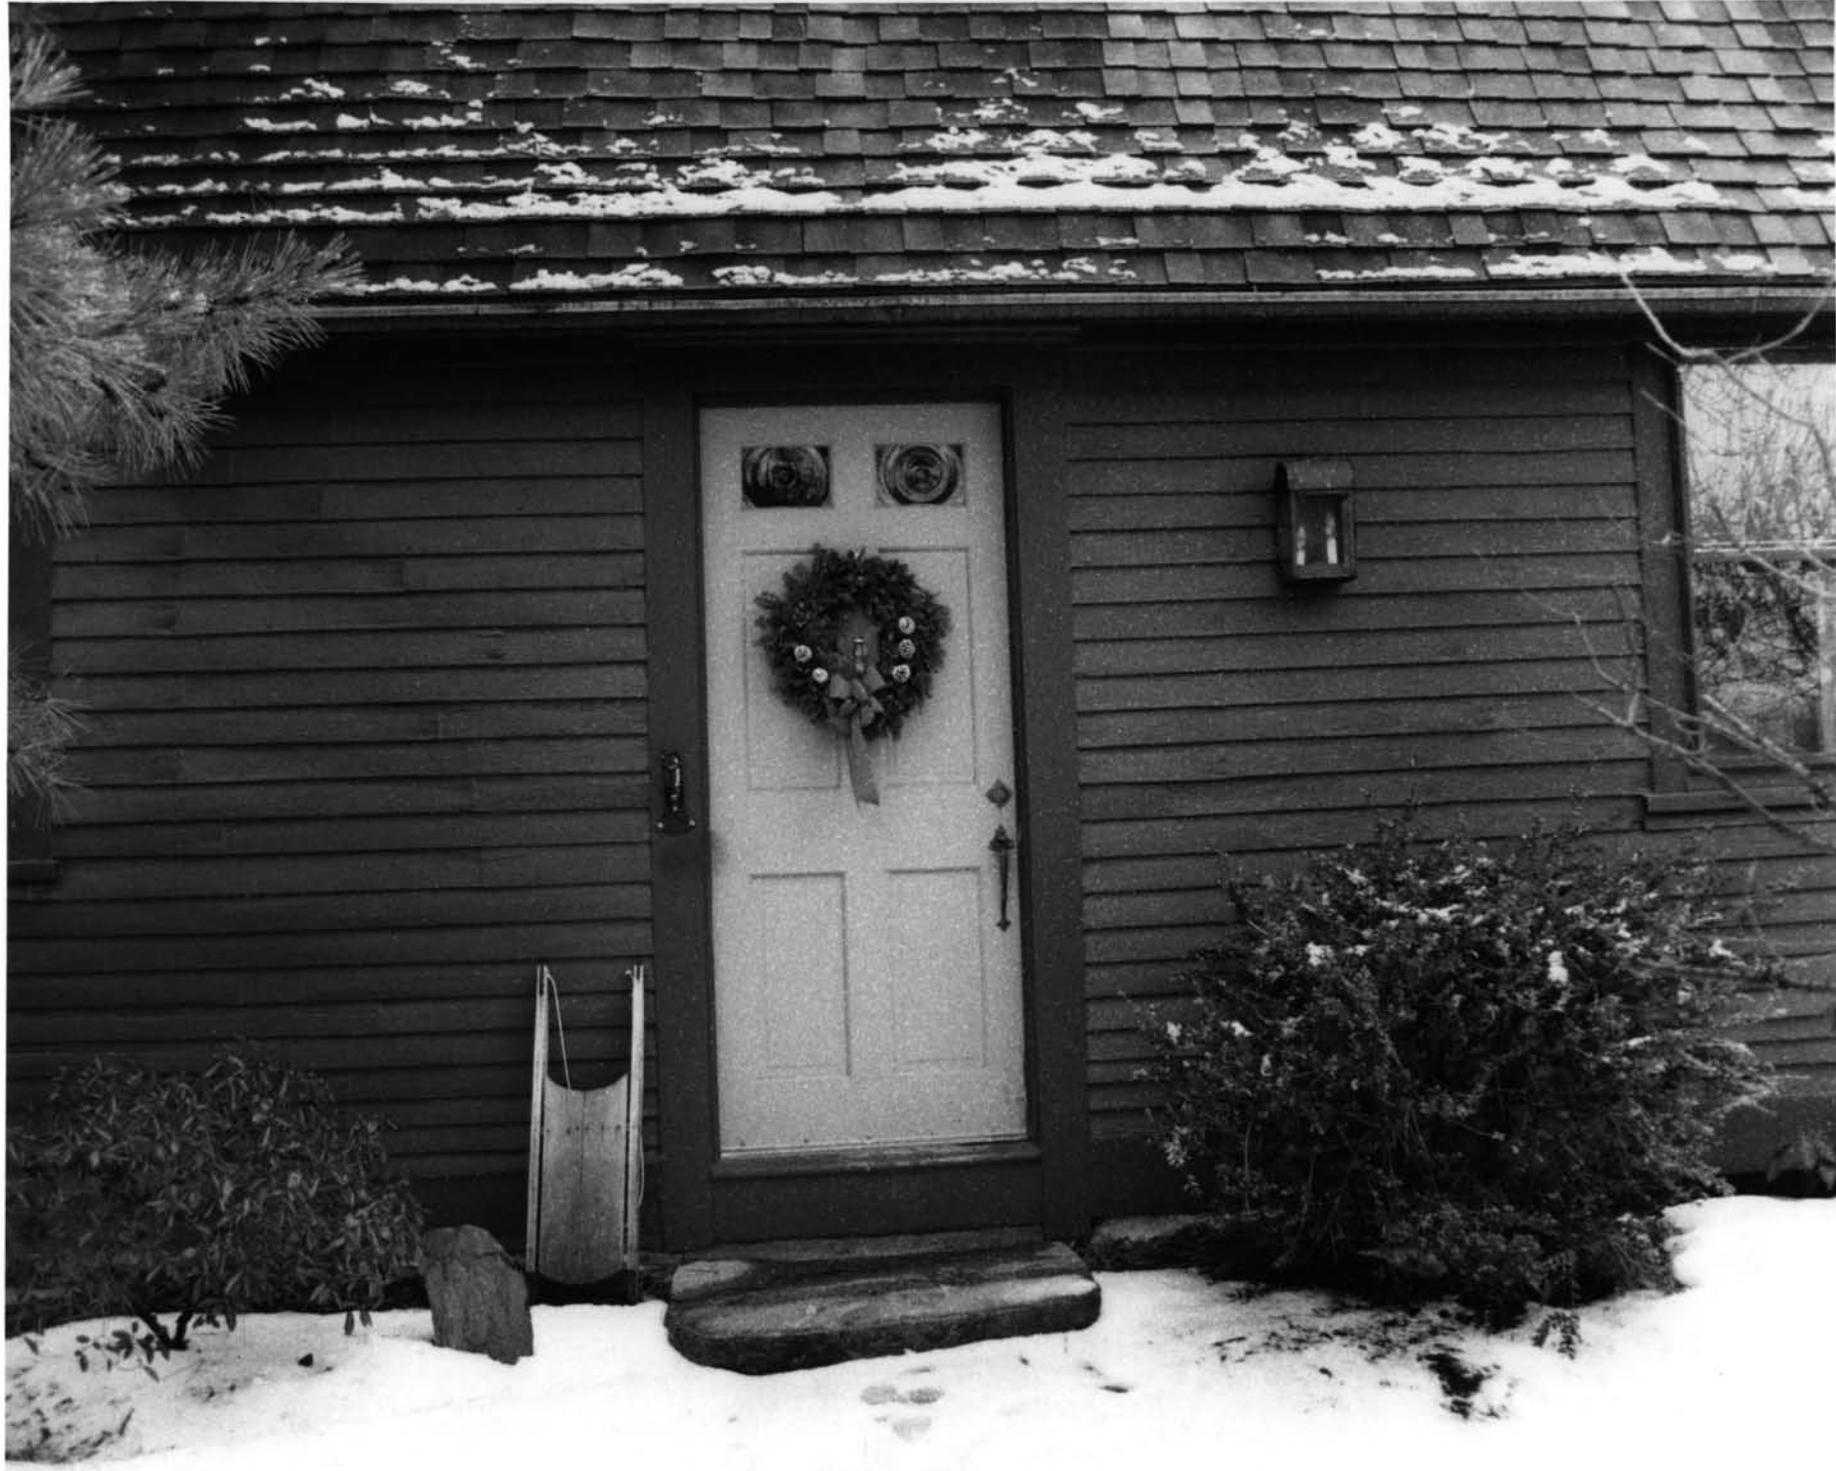
Photo #2

View: Exterior, east elevation, front door.

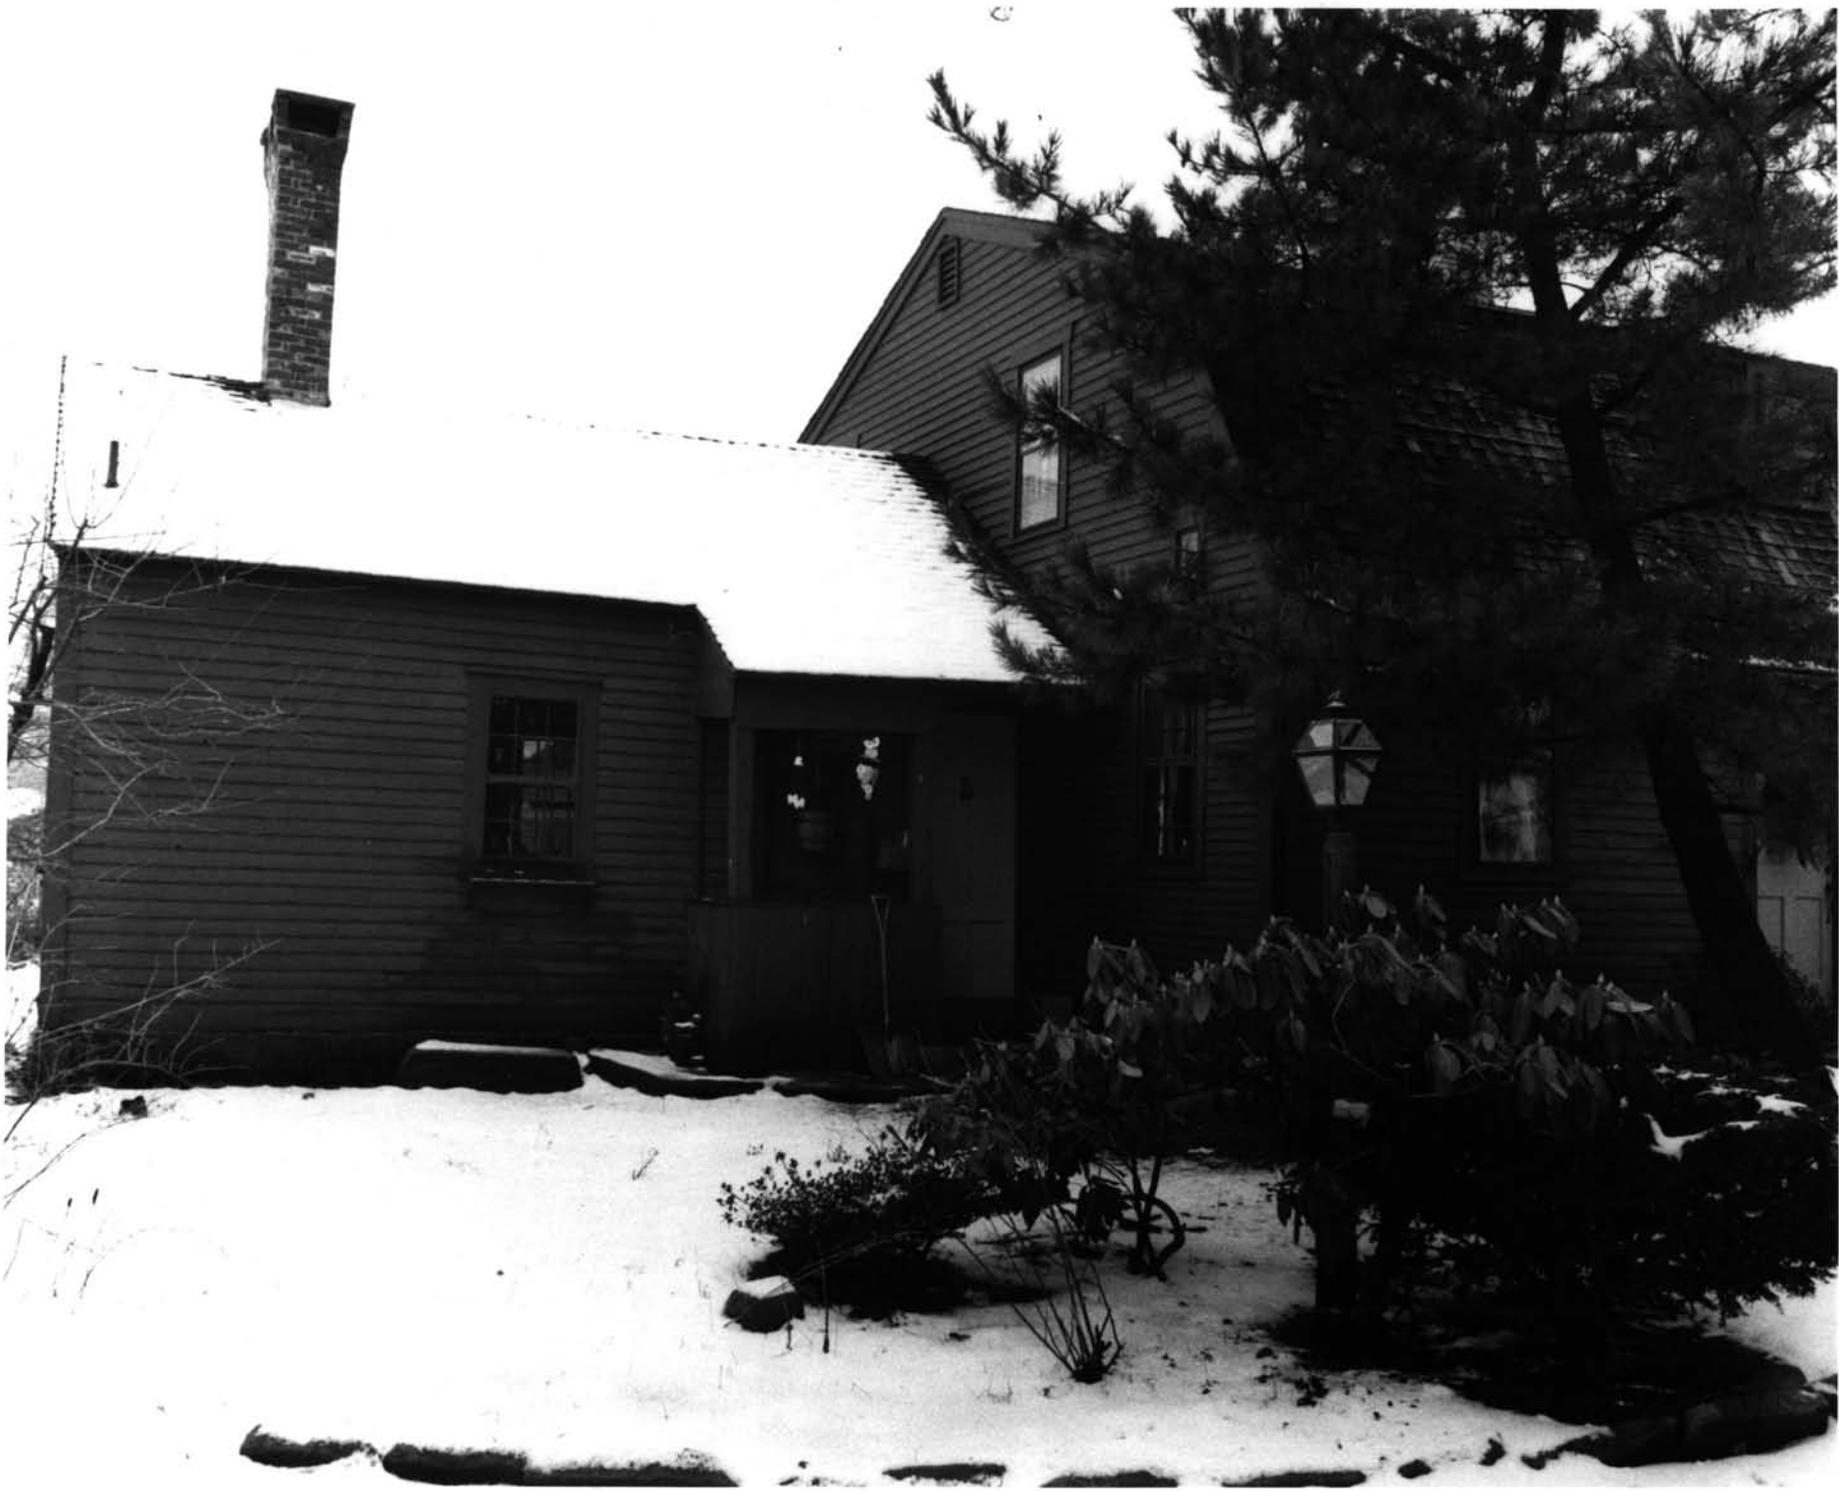
Photo # 3

View: Exterior, east elevation, showing south end of  
main house and east side of kitchen ell.

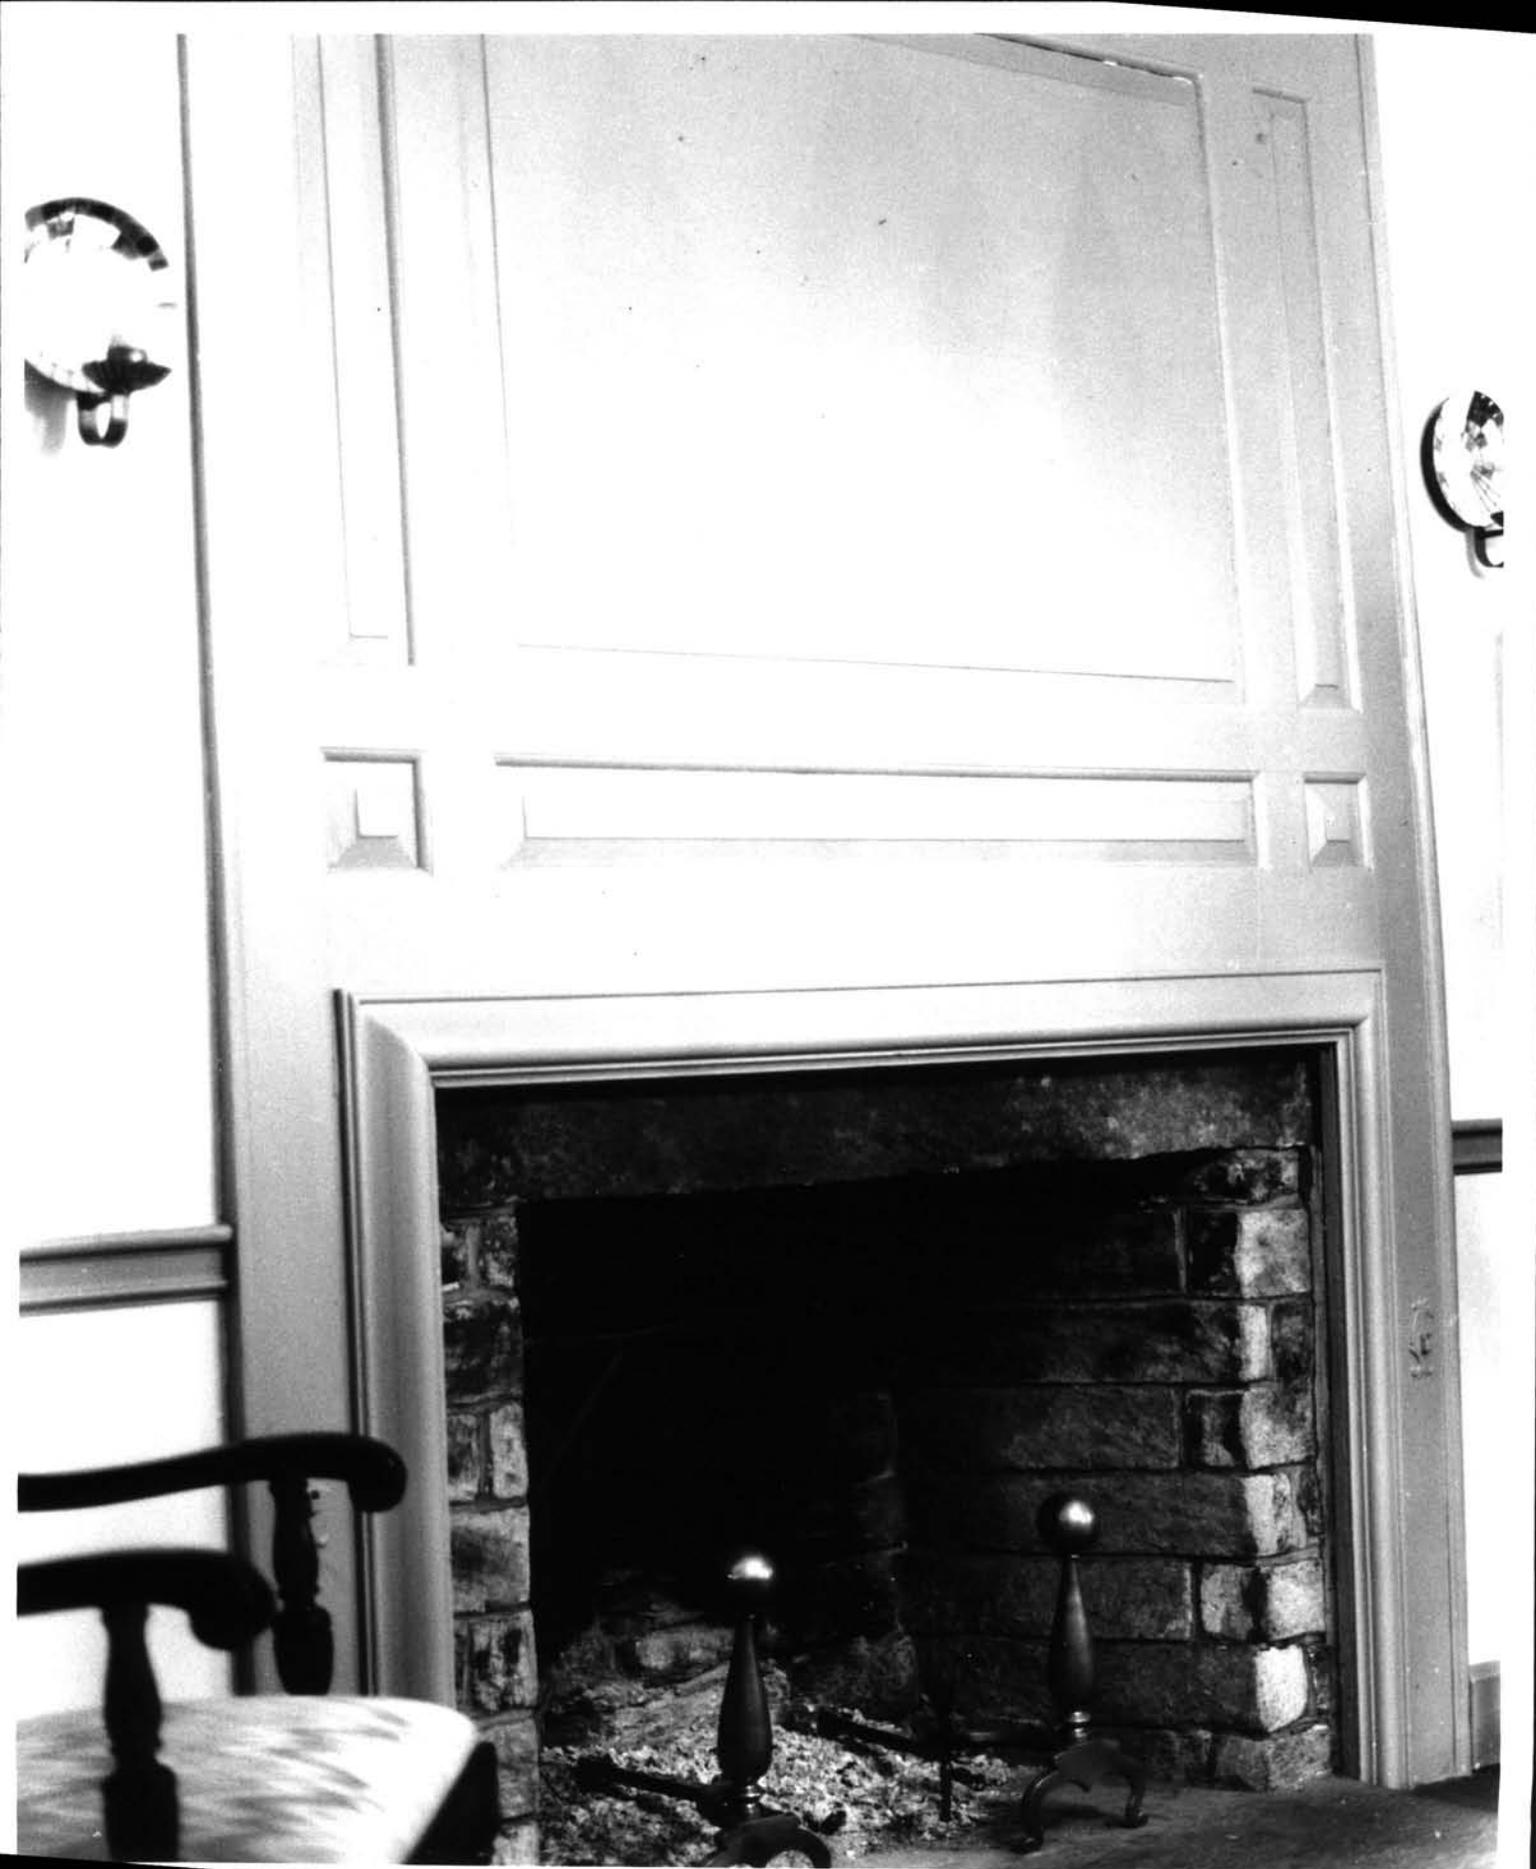
Photo #4

Views: Interior, fireplace, front chamber (dining room)

To the north of the present kitchen is the dining room. It has handsome raised, beveled paneling covering the chimney breast and a chair rail. The windows in this room have matching panelled interior shutters. The dining room has an unusual closet, perhaps at one time used for wine, faced in stone and closed off by a four-panel door. The large former summer kitchen, now an ell on the south side of the house, has its own end chimney. This room has plain board wainscoting, wide floorboards, and a very simple, wide and tall flat-board mantel topped by a narrow shelf.

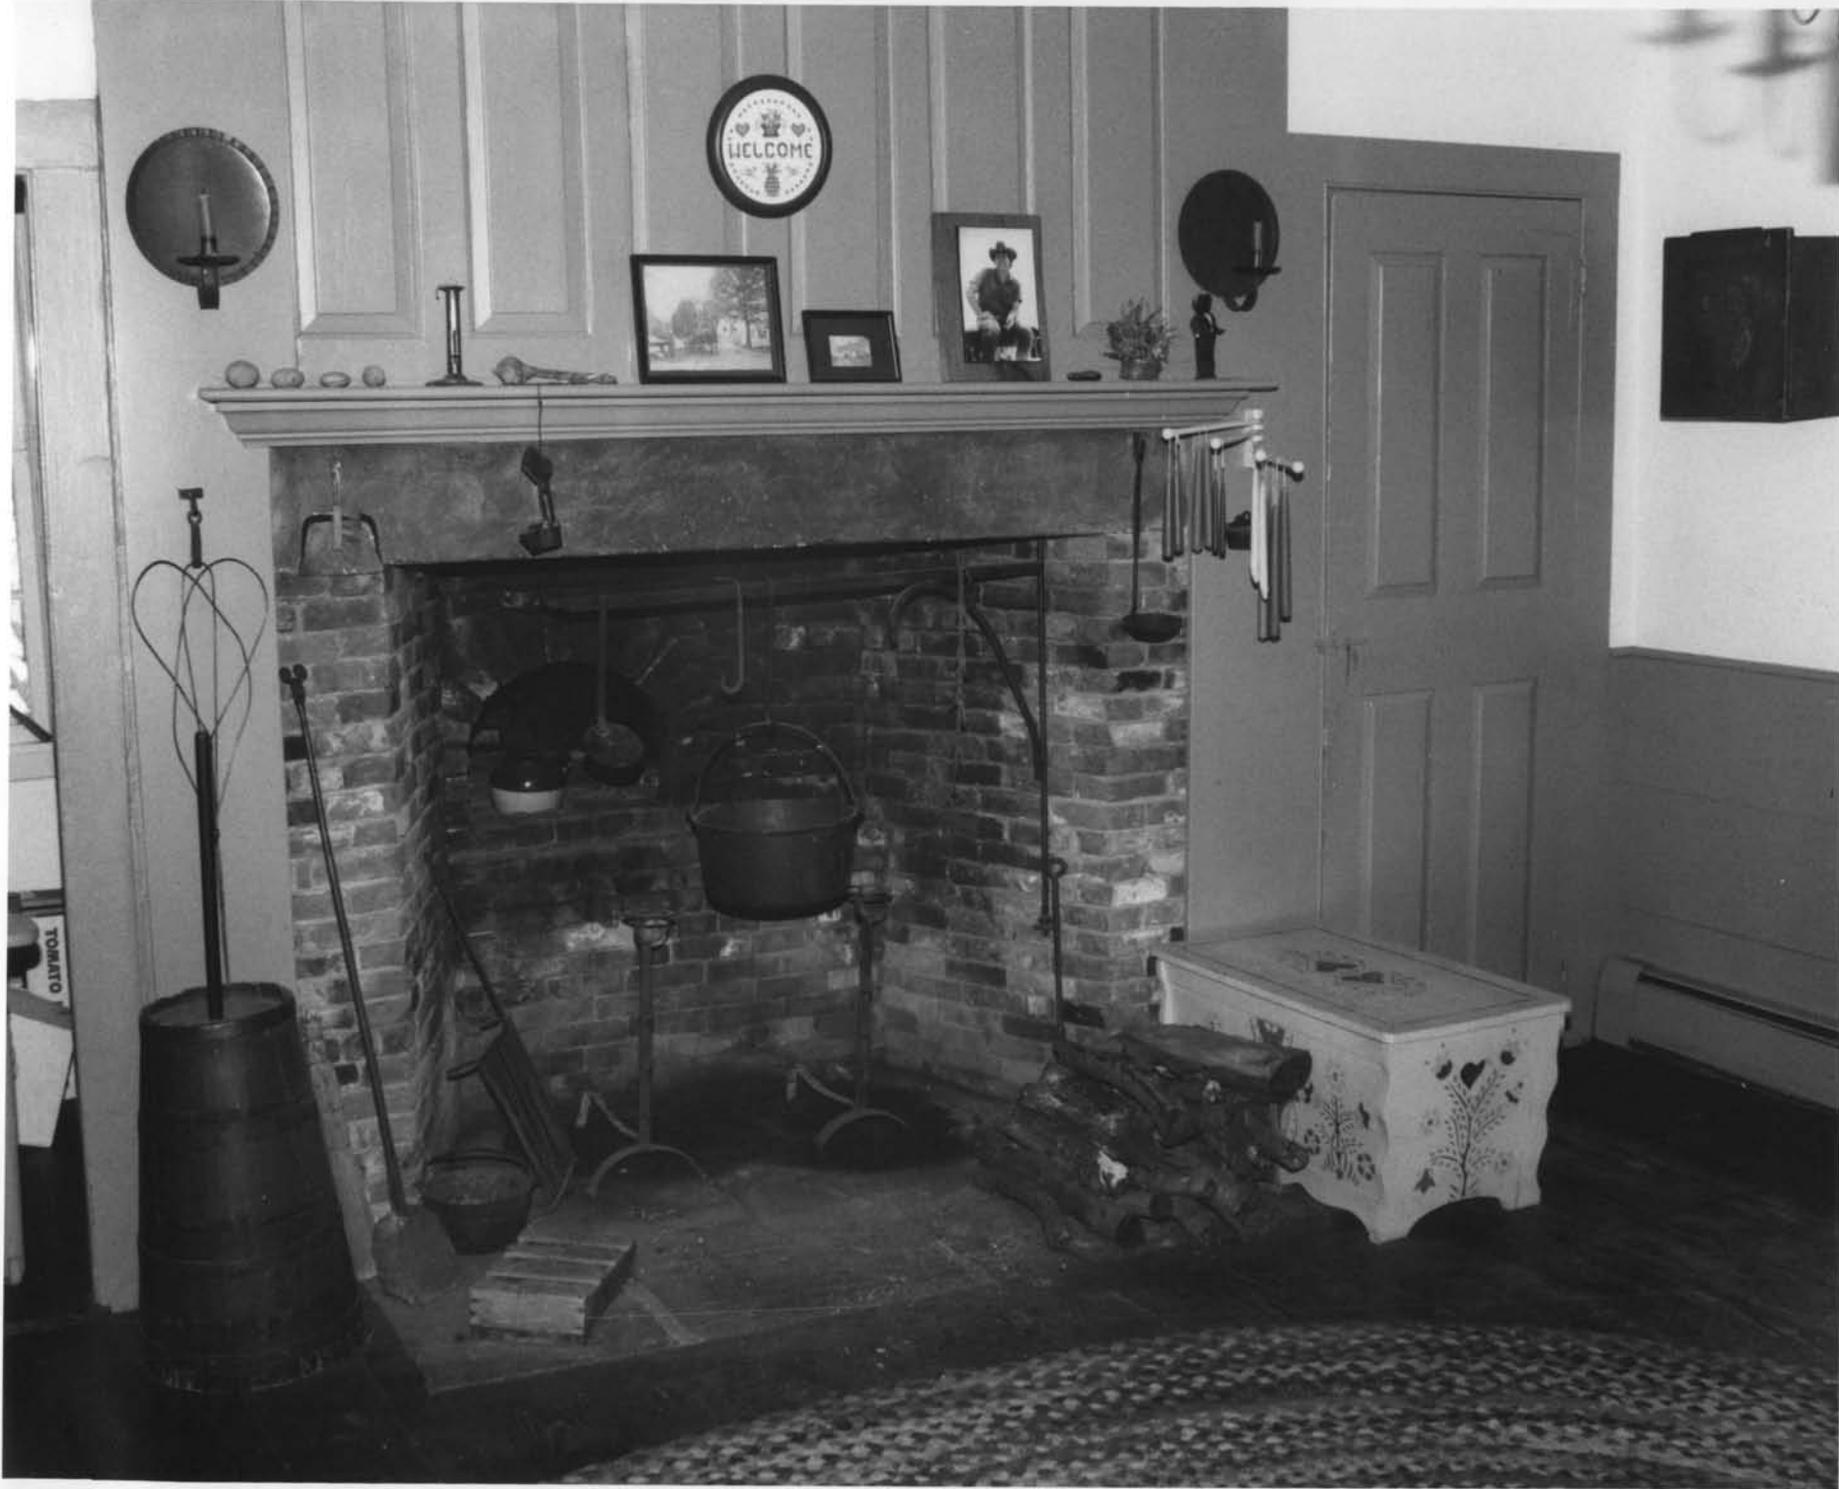
Photo #5

View: Summer Kitchen, southern ell.

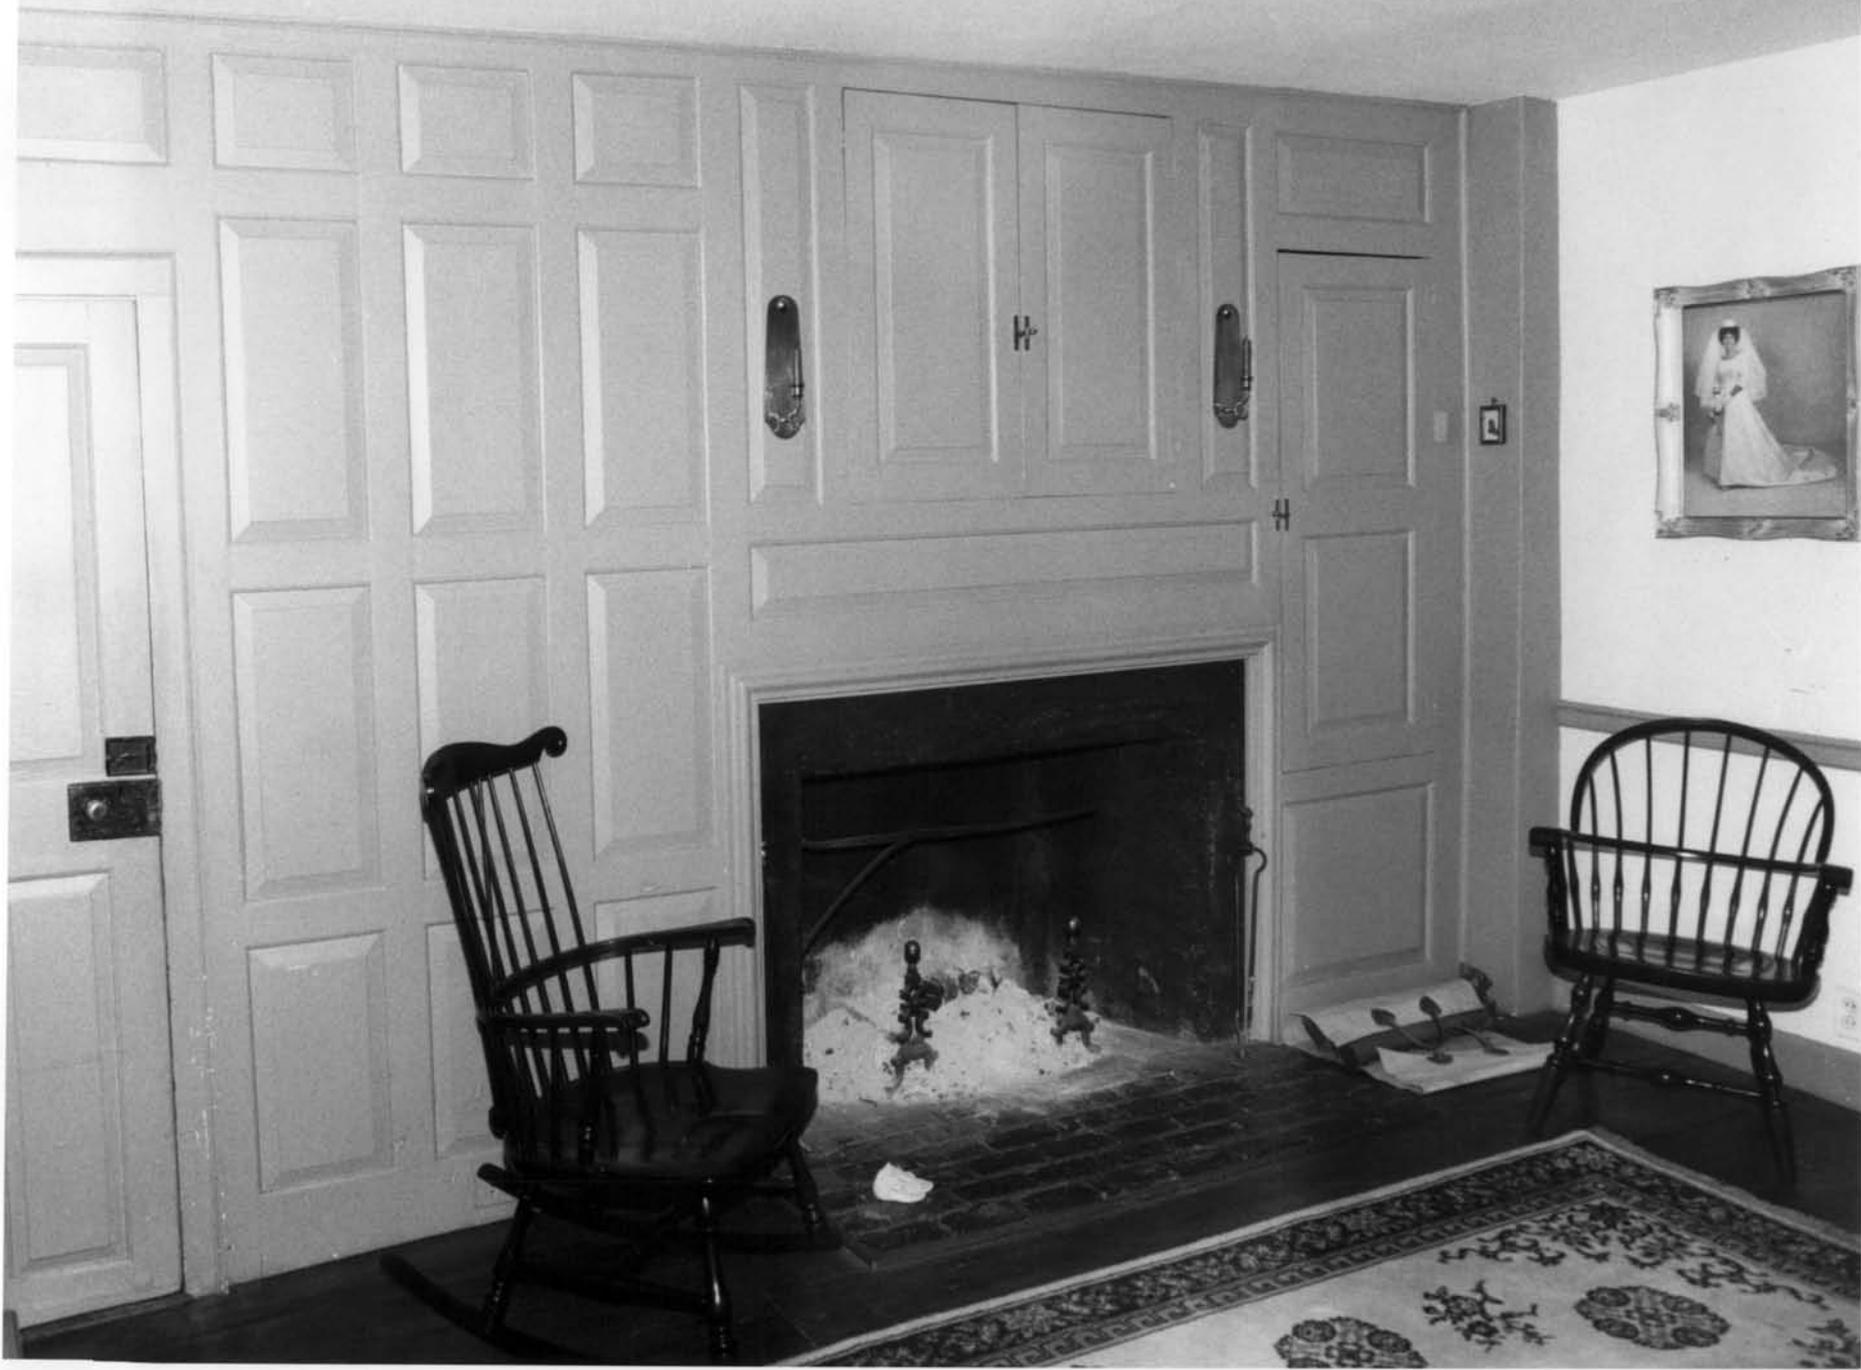
Photo #6

View: Interior, fireplace wall, northeast parlor.

To the south of the entry is the small south parlor, with a small, shallow fireplace with plain trim. In contrast, the large parlor in the northeast corner of the house has handsome beveled panelling on the entire chimney wall; a classic bolection molding surrounds the fireplace opening. At the north end is a small chamber, now a library; the room had been converted into one large space in the nineteenth century, but the wall has recently been rebuilt. To the west of the little library at the

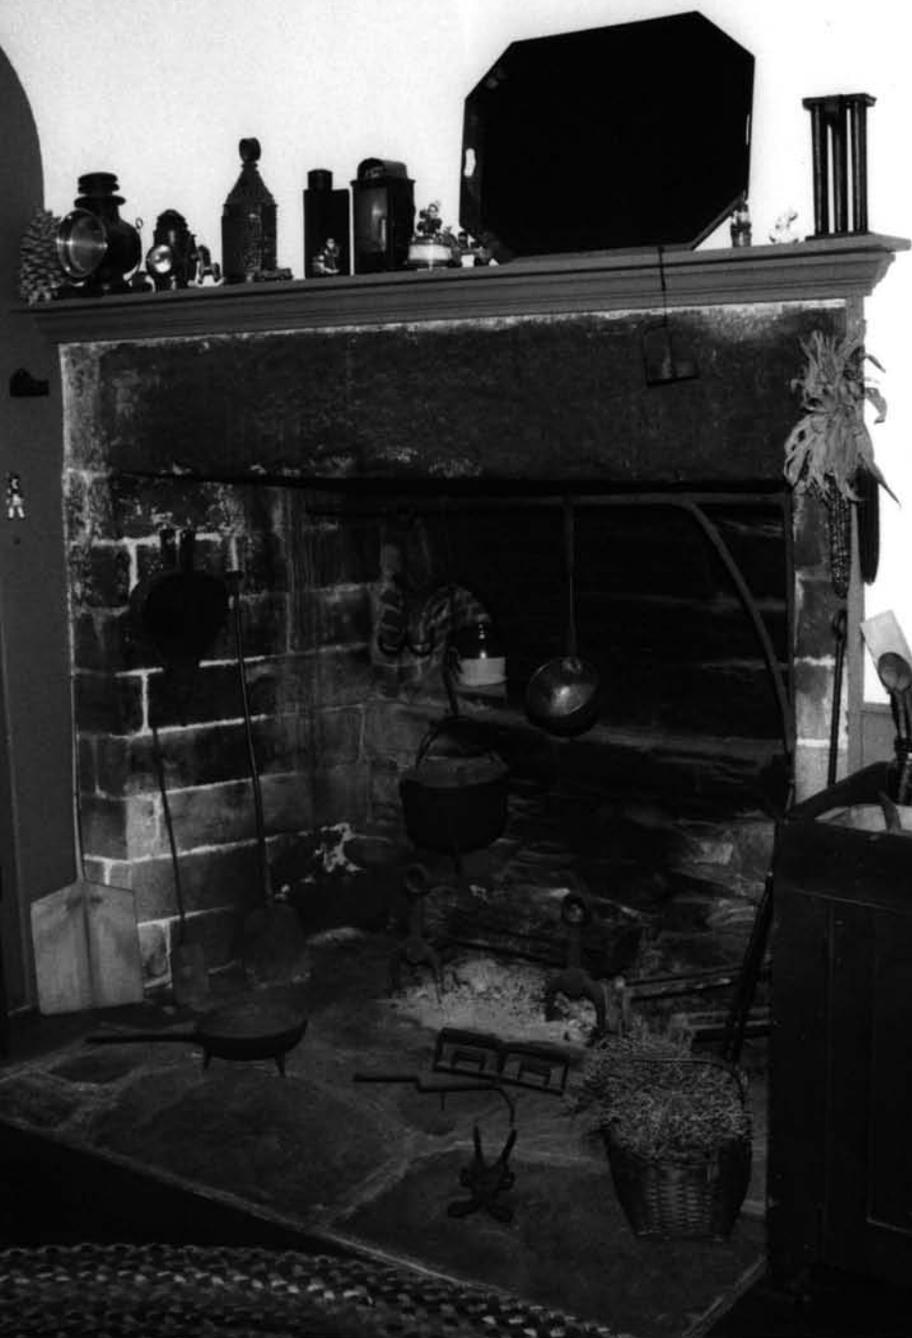
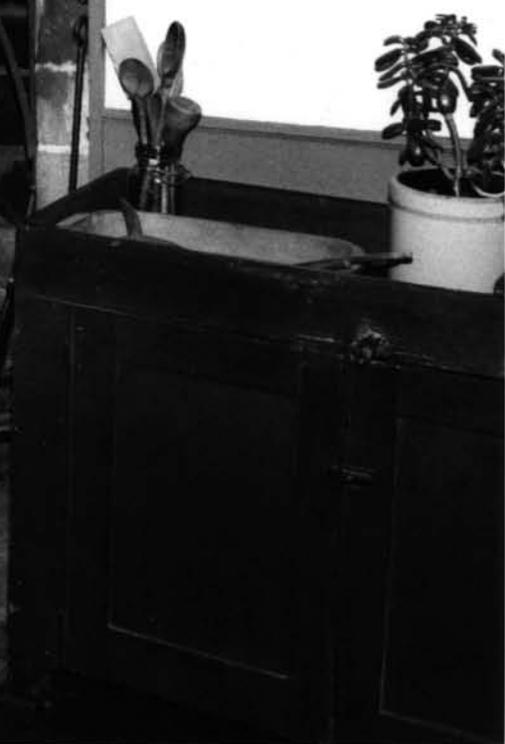
Photo #7

View: Original Kitchen, now South parlor.
