**NATIONAL REGISTER OF HISTORIC PLACES
REGISTRATION FORM**

historic name Wilbor House

street & number 548 West Main Road not for publication

city or town Little Compton vicinity

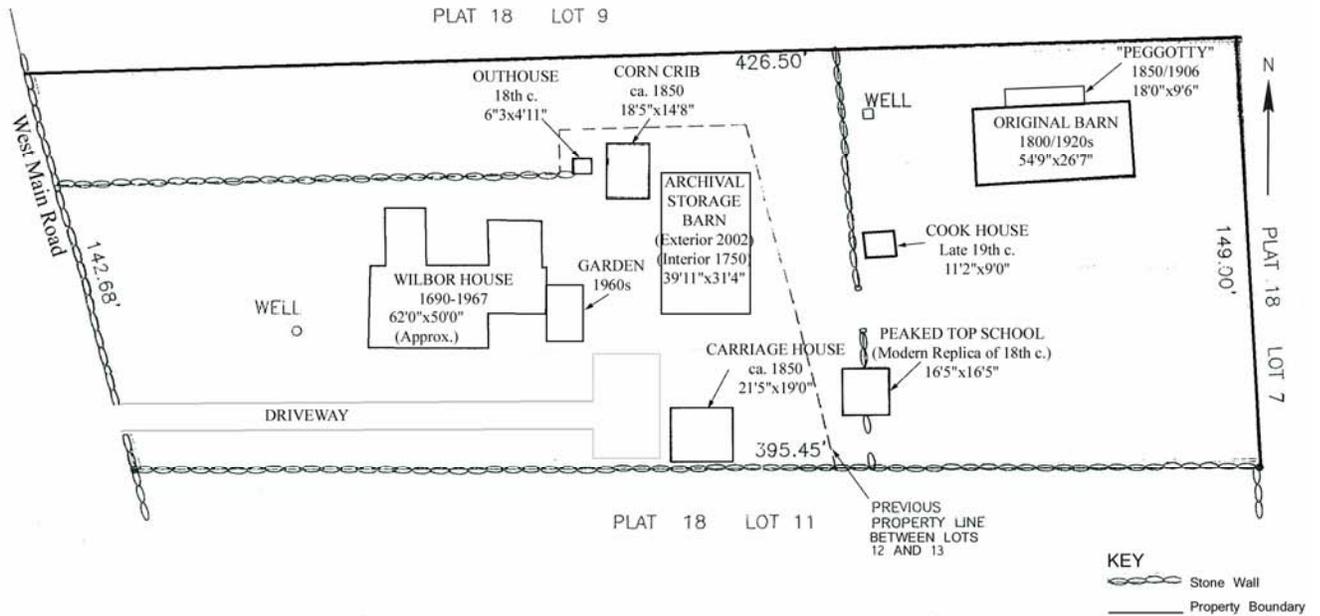
Wilbor House Site Plan

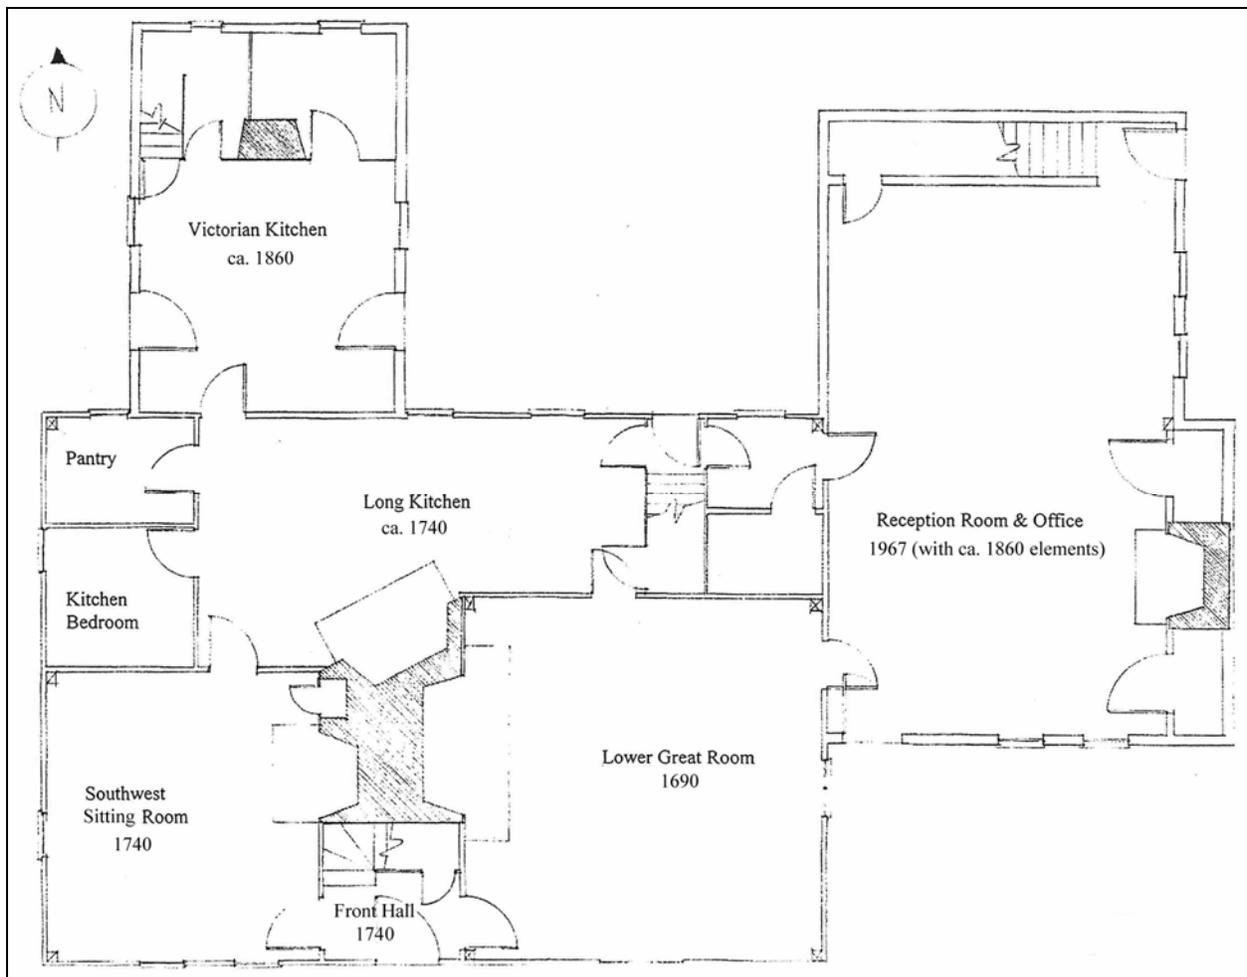
Wilbor House First Floor Plan (Marshall 1994)

The main house is divided into multiple rectangular rooms on each floor, located around the center chimney and stair and hall (Front Hall) on the south. The 1690 eastern section contains one large room on each floor (Lower Great Room and Upper Great Room) above a small cellar. The 1740 western section contains a sitting room (Southwest Sitting Room), a Kitchen Bedroom, and Pantry on the first floor; and two bedrooms (Southwest Bedchamber and Victorian Bedchamber) on the second floor. A kitchen (Long Kitchen) is located on the first floor between the Pantry and Kitchen Bedroom in the northwest corner of the house and a restroom and stairwell in the northeast corner. This room dates to approximately 1740, but evidence in early documents and local historians suggests that an early ell addition was located at the east section of the room and the structure of this early addition may have been incorporated into the 1740 room. A Storage Room is located above the Long Kitchen on the second floor with a stair in the corner to the unfinished attic.

The Lower Great Room is an approximately 19-foot by 19-foot square room with a stone fireplace in the center of the west wall. All of the structural and finish wood in the room is unpainted and exposed. An original chamfered summer beam runs east-west through the room and is flanked by north-south joists. The underside of the wide floor boards for the floor above also serve as the Lower Great Room ceiling. These boards are laid in the same direction as the summer beam, opposite from the north-south boards on the floor of the room. The fireplace is constructed of irregularly coursed fieldstone, Portland cement mortar, and a fieldstone hearth. The back wall and hearth of the fireplace is original. The sides of the firebox have typical seventeenth- and eighteenth-century flared walls. The opening of the fireplace is 7 feet wide at the front and 2 feet deep. Vertical wide board paneling flanks the fireplace. The Lower Great Room is accessible through three door openings. A door constructed of two, wide, vertical feather-edge boards with strap hinges in the southwest corner of the room leads into the Front Hall. Another door of the same design in the center of the north wall provides access into the Long Kitchen. The third wood door is located in the northeast corner and opens into the Reception Room. All of the doors are historic.

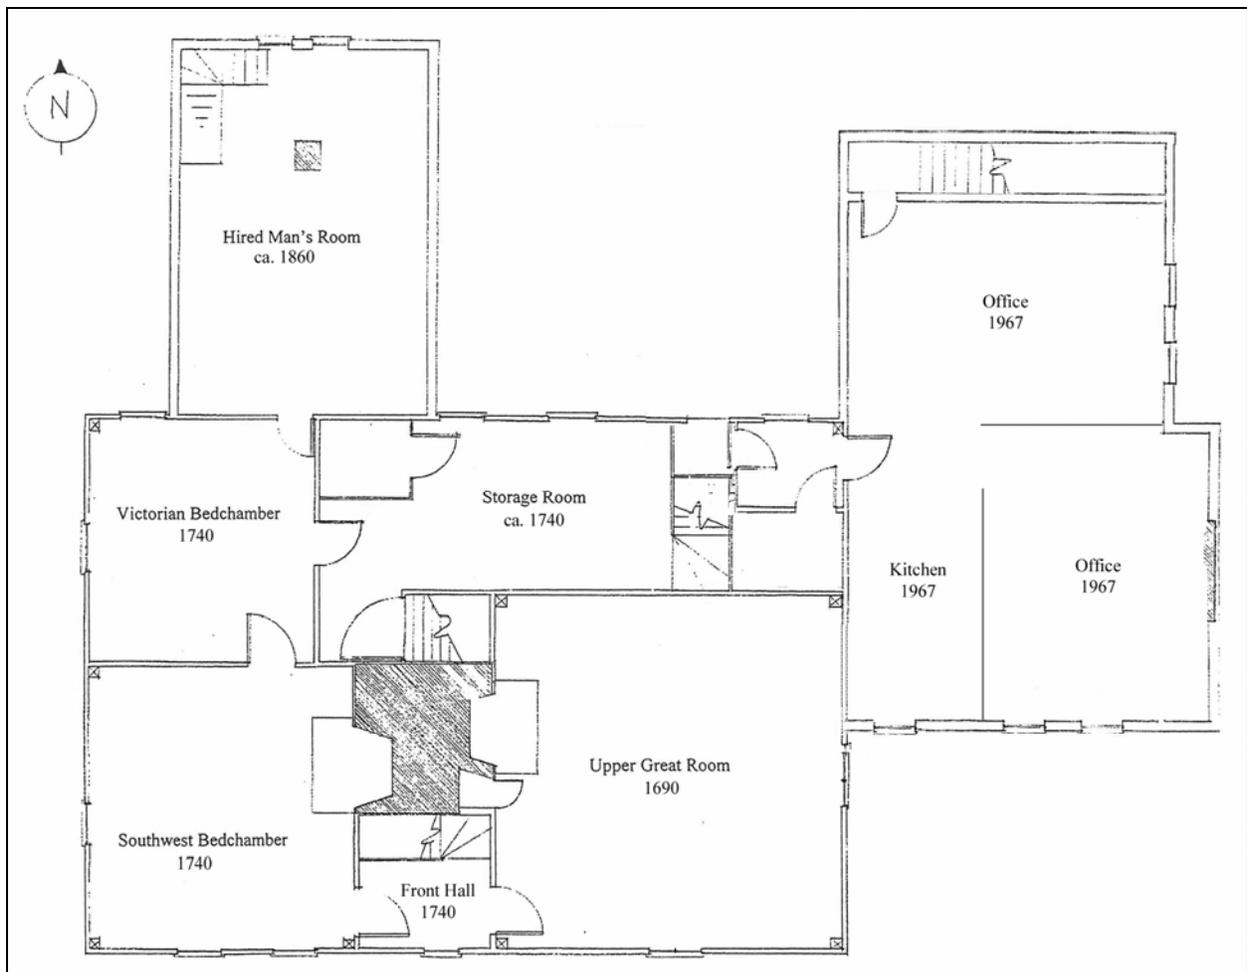
Wilbor House Second Floor Plan (Marshall 1994)

The Upper Great Room is an approximately 19-foot by 19-foot square bedroom with a brick fireplace in the center of the west wall. All of the structural and finish wood in the room is unpainted and exposed. The ceiling has exposed framing with an original north-south oriented summer beam, the walls consist of plaster with original exposed gunstock posts, and the floors are constructed of original, wide east-west oriented boards. Diagonal braces between the posts and girts are visible at each corner of the room. The historic fireplace may date later than the room. The west wall featheredge boards and a horizontal, recessed picture panel located above the fireplace are original. A replacement batten door to the south of the fireplace opens into a narrow closet with multiple wood shelves. An original batten door constructed

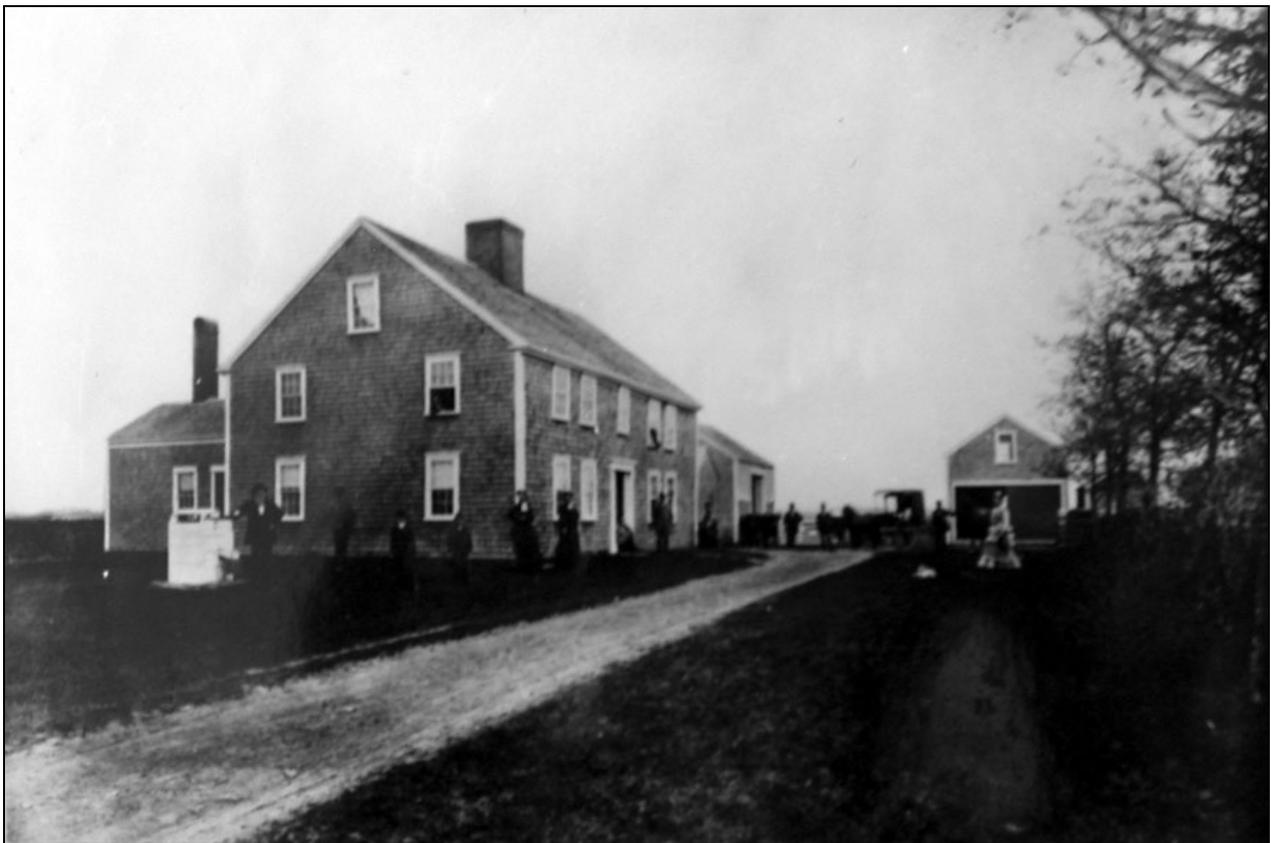
View of Wilbor House in 1876, looking east from West Main Road (LCHS)

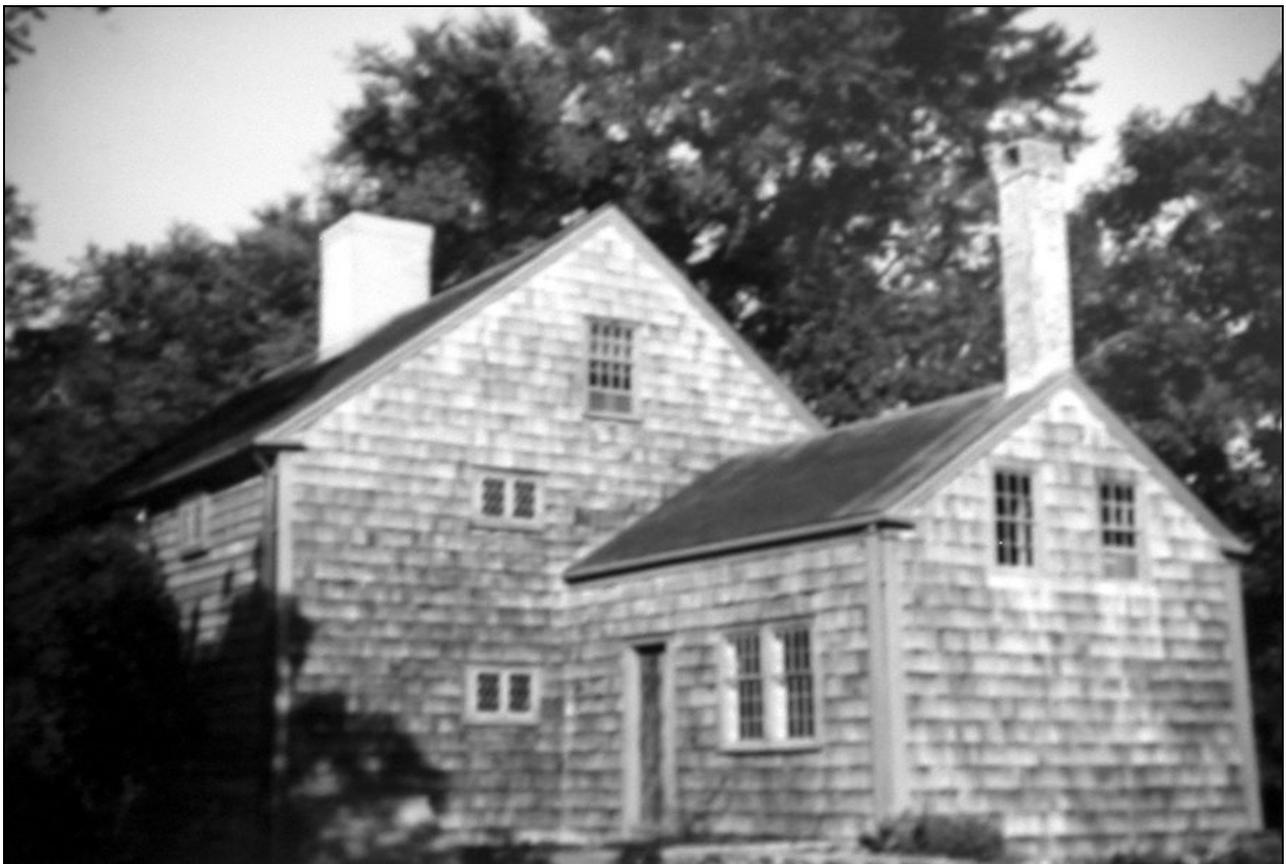
East Elevation of Wilbor House during restoration, circa 1955 (LCHS)

The LCHS carefully restored the exterior of the Wilbor House between 1955 and 1957, with additional window modifications in 1991. Restoration included replacement of damaged exterior wall and roof cladding, structural repairs, and the replication and restoration of original windows and doors. Fenestration evidence found in the main house included: original, smaller window openings; an original diamond-pane casement window opening at the second story of the south elevation; original 12-over-12 windows stored in the attic of the house; and one intact window in-situ on the north wall.

When Brownell initiated the restoration of the Wilbor House in 1955, he hired local contractor Isaac Bliss and his son Ambrose to help with the work. Isaac had experience working on several restoration projects, and had practical knowledge on how to conduct restoration work with minimal alteration or damage to historic fabric. Bliss and Brownell finished the exterior restoration of the Wilbor House in 1957, and the LCHS opened the building while interior restoration work was ongoing for the following few years. Brownell and the LCHS continued restoration of the rest of the buildings on the Wilbor House property with the same methods in the later decades of the twentieth century.
