National Register of Historic Places Registration Form

historic name Honan's Block and 112-114 Main Street

street & number 110-114 Main Street

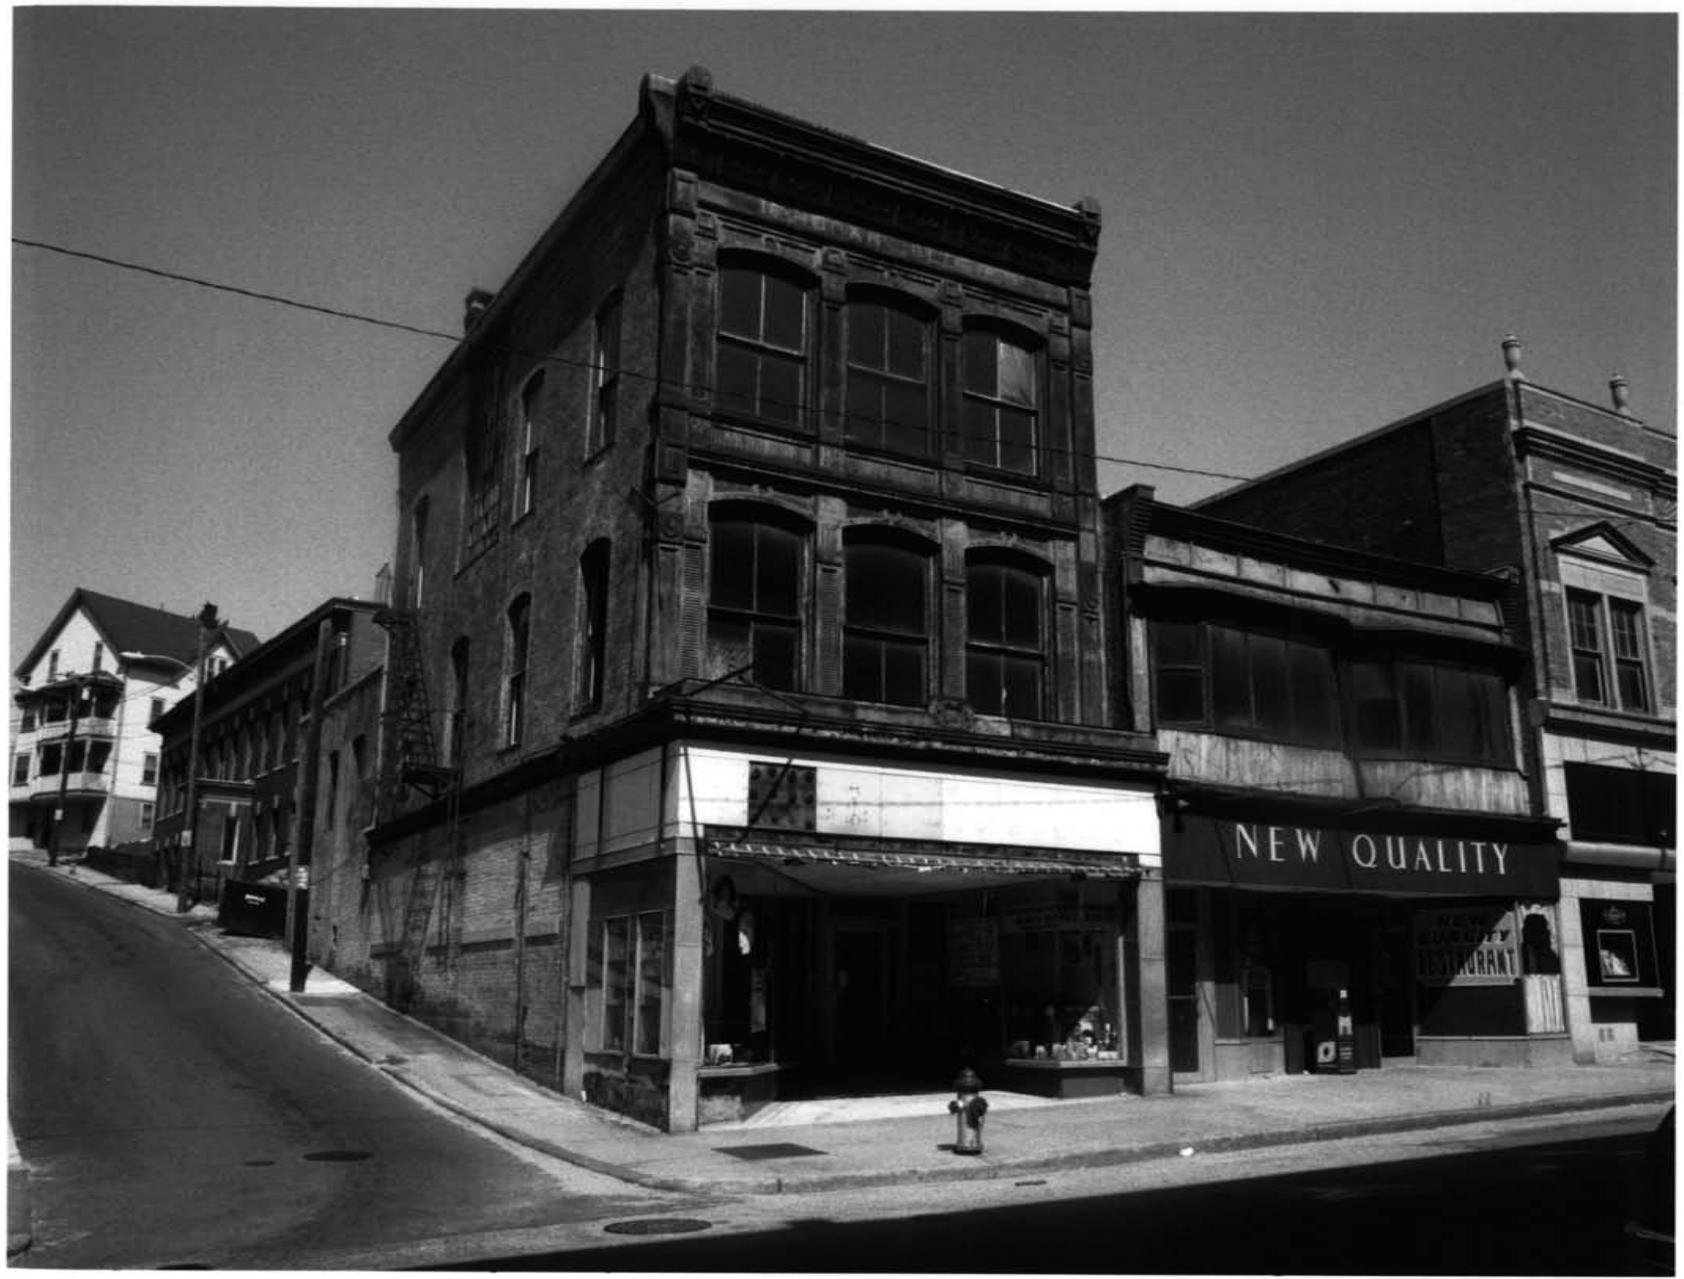
Photo #1

Views: Main Street elevation, view northwest.

Occupying a corner lot on the northwesterly side of Main Street, Honan's Block and the unnamed block at 112-114 Main Street is a small, two- and three-story, flat- and low-pitch-gable-roofed, brick Late Victorian commercial block. It consists of two visually distinct, but interconnected buildings: Honan's Block (108-110 Main Street), constructed in 1879 in the Eastlake style, and a simpler building, 112-114 Main Street, constructed between 1895 and 1911. The buildings are typical urban commercial structures, sited at the sidewalk edge with an abutting building to the northeast and Ascension Street, a narrow thoroughfare, to the southwest. Honan's Block proper occupies its entire rectangular lot; 112-114 Main Street is an L-plan building which extends across the rear of Honan's Block and abuts its own rear lot line. Demolition of a structure which stood on a separate parcel to the northwest has created a rear service area off Ascension Street. Although Honan's Block proper, with its distinctive cast-iron front, is the more visually striking of the two buildings, their interior spatial linkage, resulting from modifications of 1938/39, requires that they be treated as a single unit for nomination. Together, the two buildings reinforce the continuous vertical line of commercial facades along Main Street immediately southwest of the Harris Block/City Hall (listed in the National Register, 1974).

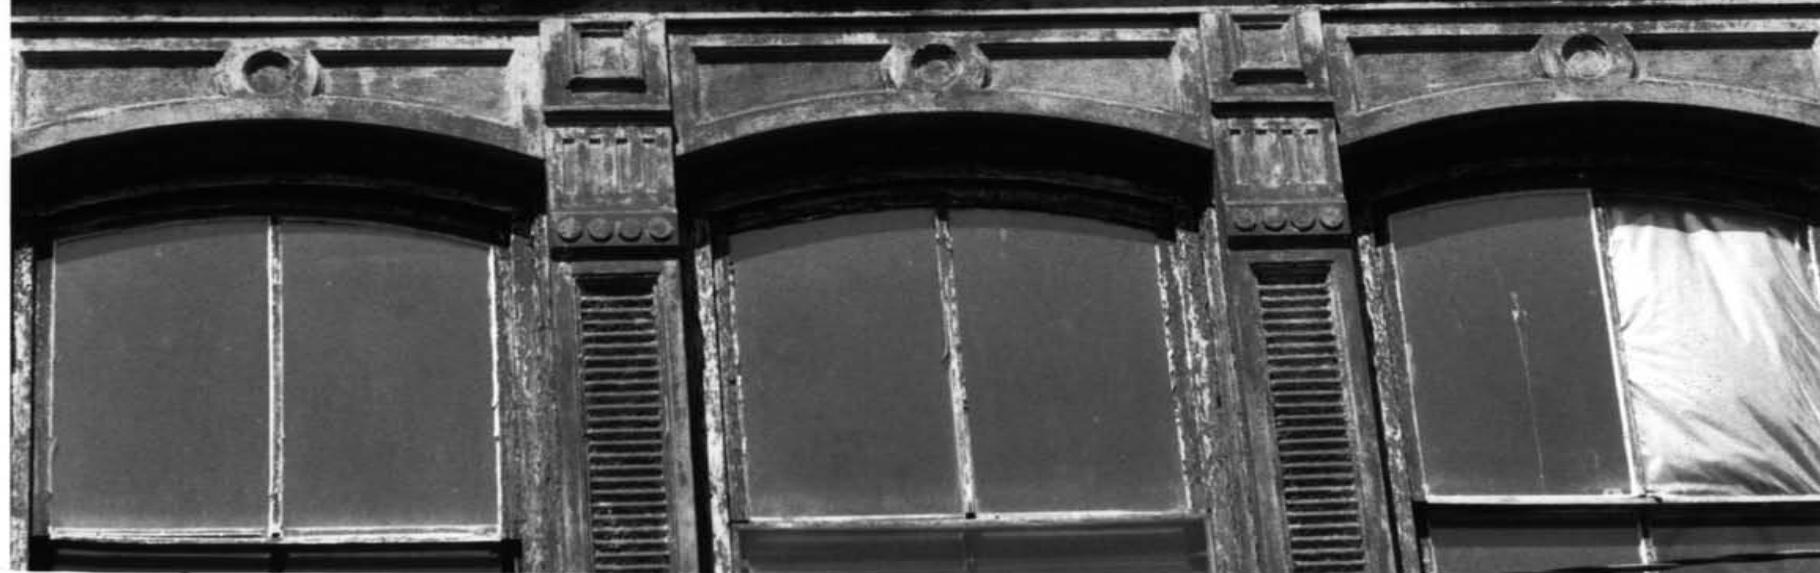
Photo #4

View: Cornice detail, view west.

The side and rear elevations are of red brick laid in running bond. On Ascension Street (southwest), a molded wood stringcourse above the first story continues the line of the store front. Double rows of sawtooth brickwork surmounted by molded wood trim form the cornice. Four windows with trabeated granite lintels and sills on the first floor have been filled in. The fenestration of the upper stories of the three-story block generally follows a symmetrical pattern, with four bays of regularly spaced windows. Seven of these bays contain segmental-arched windows on the second and third stories. In one bay on the third floor, instead of a segmental-arch window, there is a large, multi-paned rectangular window extending up to the cornice. This window was either part of the original design or

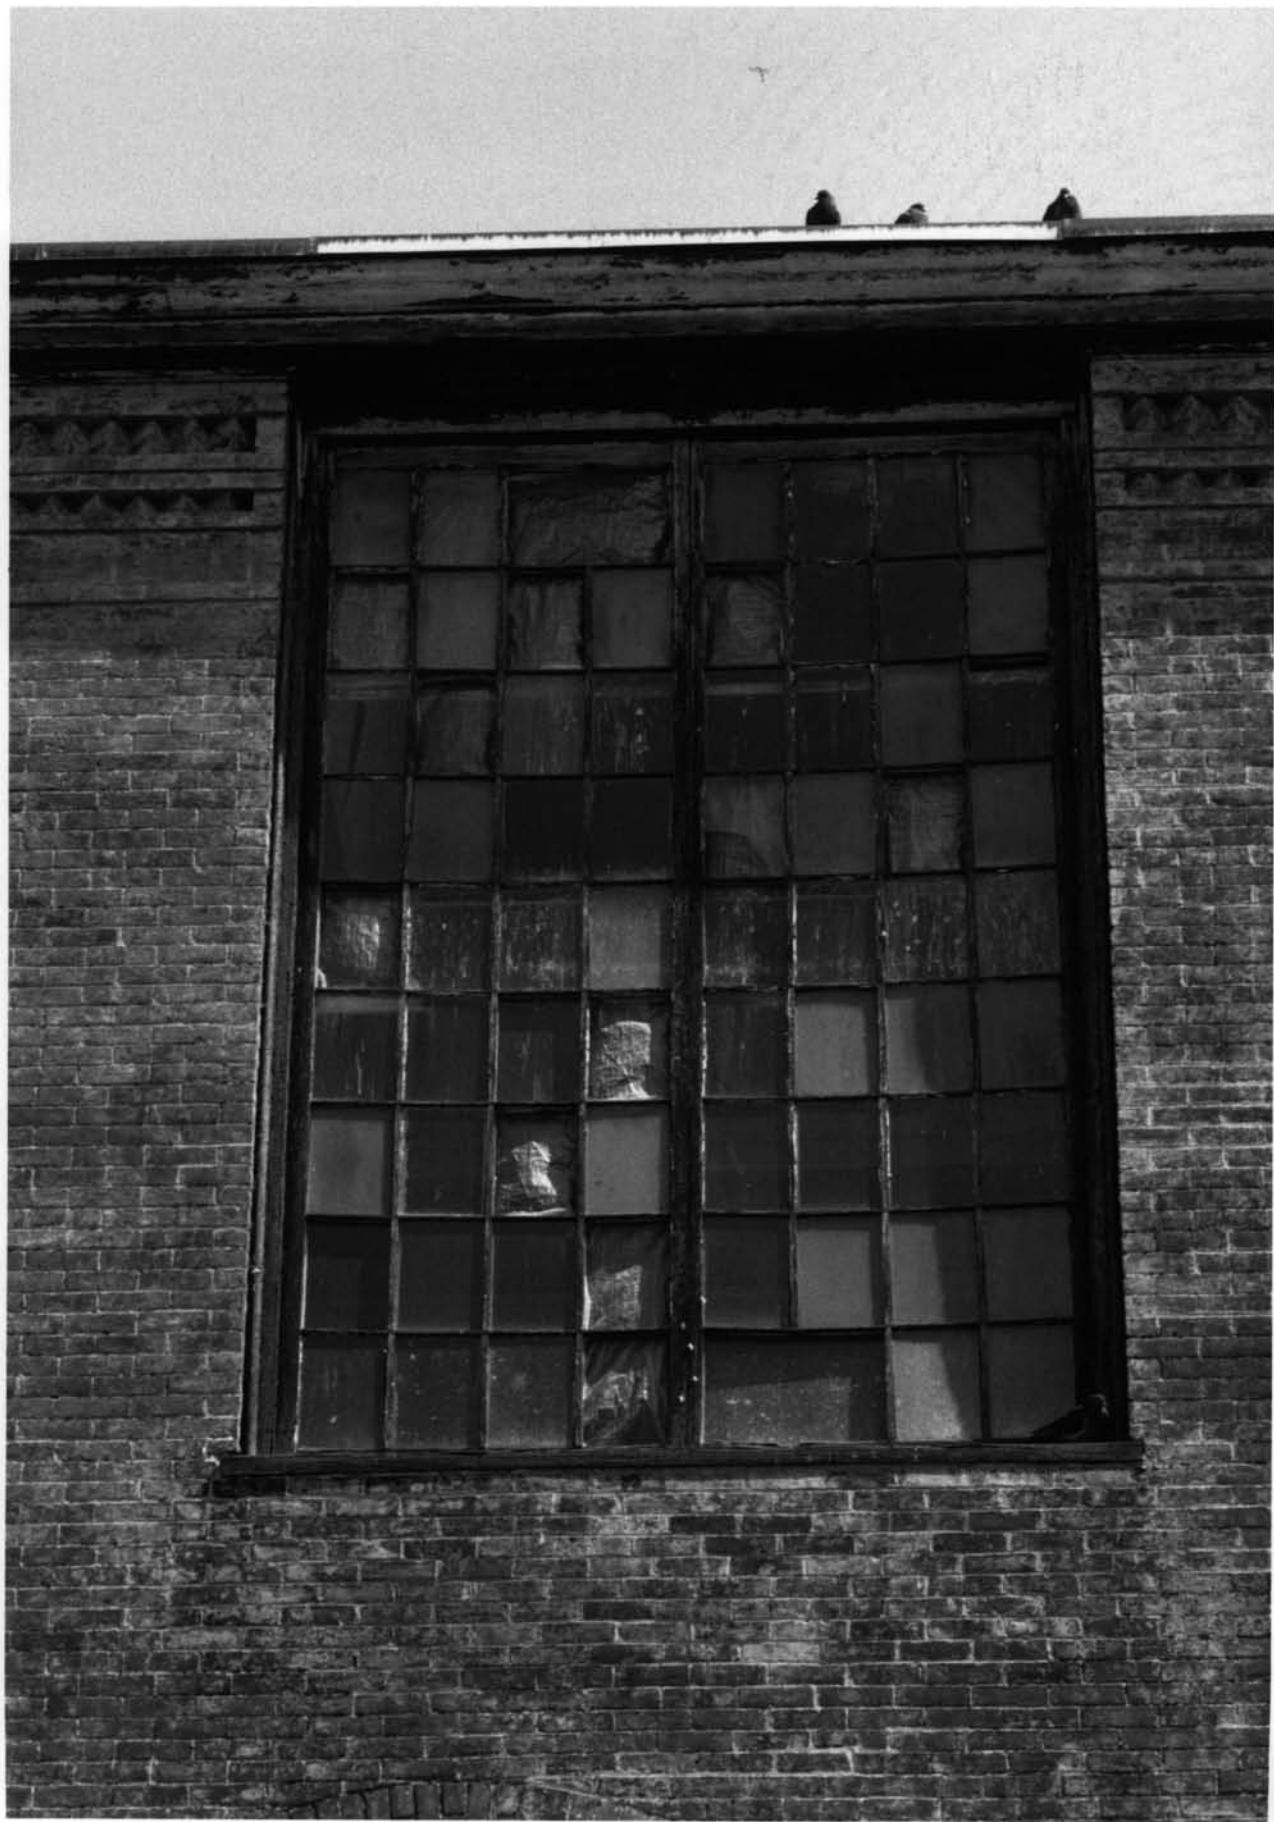
Photo #3

View: South elevation detail, view north

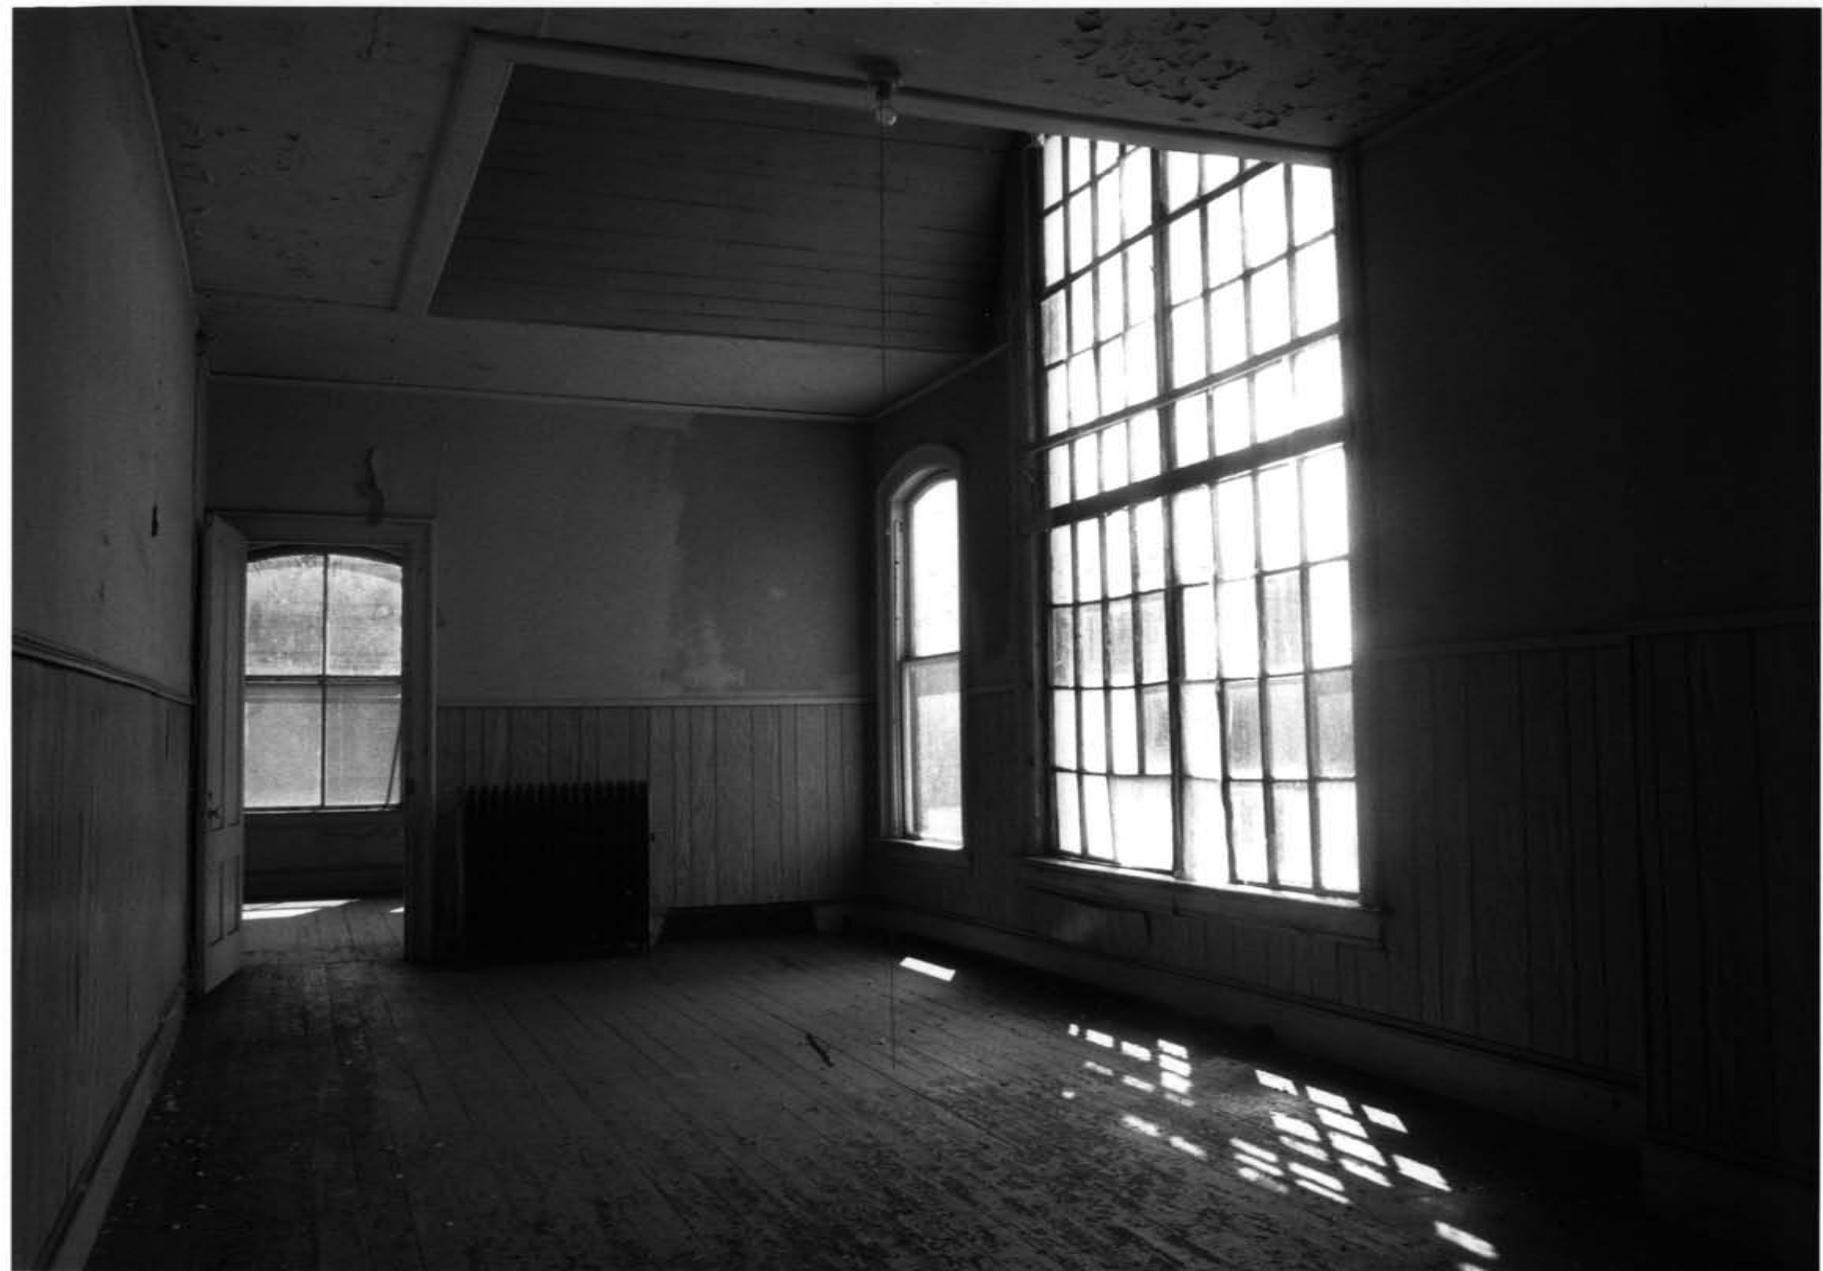
Photo # 8

View: Interior, third floor photography studio,
view southeast.

The building's high ceilings, large windows, and transom panels above interior doors maximize natural light. One of the most interesting aspects of the design is the third floor, which appears to have been built specifically to house a photography studio. The stairhall leads into the front, or east, office overlooking Main Street. This in turn leads into the south room which appears to have functioned as the studio. Here, the immense floor-to-ceiling window which extends into a skylight (now covered over) and southern exposure create an extremely well-lit work space. A small room at the northwest corner of the building now used as a bathroom functioned as the darkroom. Black wall paint and scars of counters and shelving remain, as does a small, eye-height pass-through door into the stairhall. The door may have been used to receive exposed plates for processing or to communicate with customers approaching the main office door.

The distinctive and unaltered elements of the Honan's Block studio space exist as a valuable record of the technological requirements of commercial photography in the late 1870s. At that time photography techniques relied primarily on the "wet plate" negative process and on the sun for plate exposure. Dry glass plate negatives first appeared in the early 1870s, but did not immediately become widely used; wet plate negatives required that the darkroom processing be completed promptly following exposure. Although several forms of artificial light for indoor shooting were available, the sun was the quickest and most economical light source. In this period prior to George Eastman's development of a practical roll film system (1884) and the kodak camera (1888) which introduced amateurs to photography, professional photography was at its zenith. Although the subject has not yet been systematically studied, it seems that nineteenth-century commercial photographers preferred to occupy either first floor studios in order to capitalize on walk-in business, or top floor spaces to take advantage of natural light. The location of the Honan's Block studio on an upper floor reflects the latter tendency.

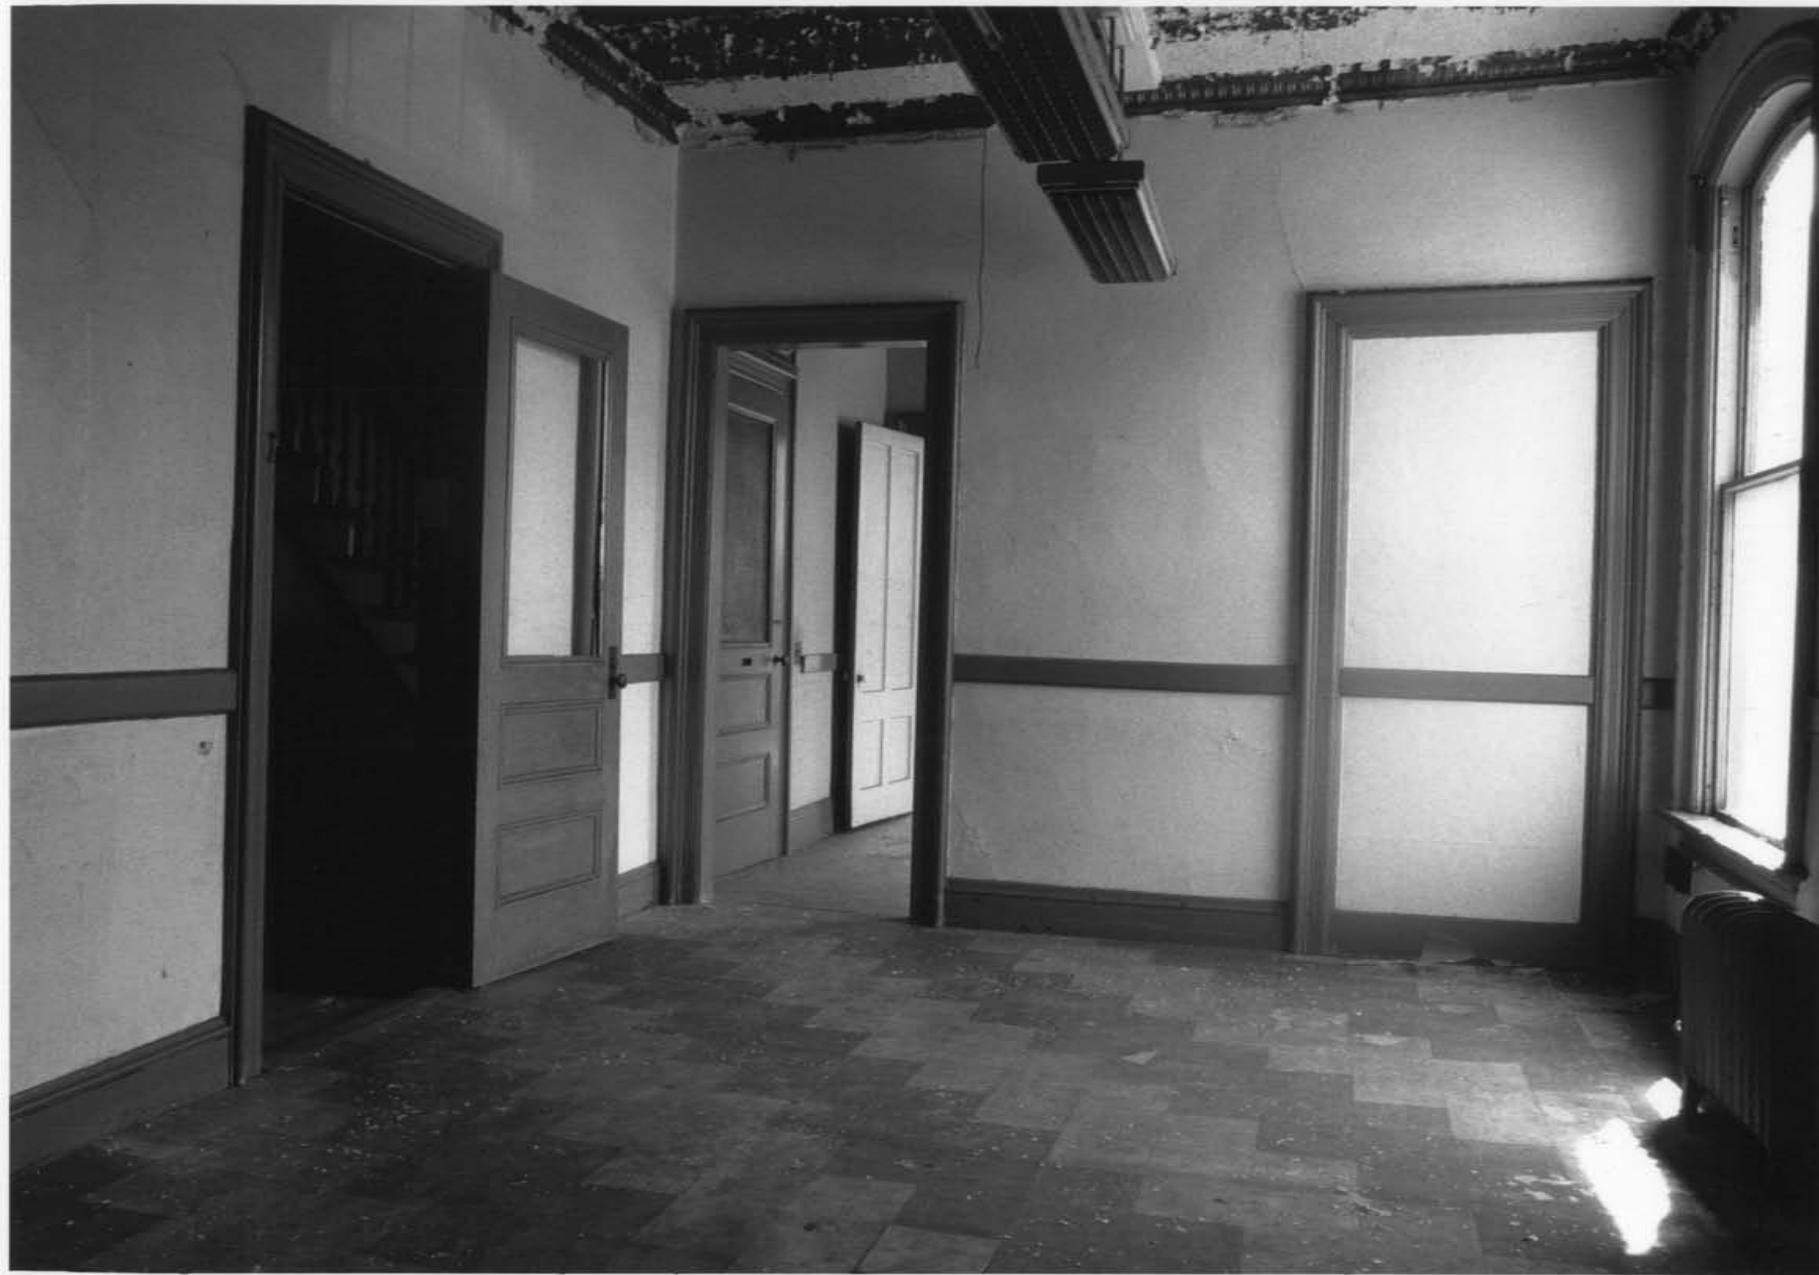
Photo # 7

View: Interior, second floor office, view east.

Original interior finishes include two-inch pine floor boards, plaster walls, and decorative pressed-tin ceilings. Original wood trim remains throughout including the turned balusters and

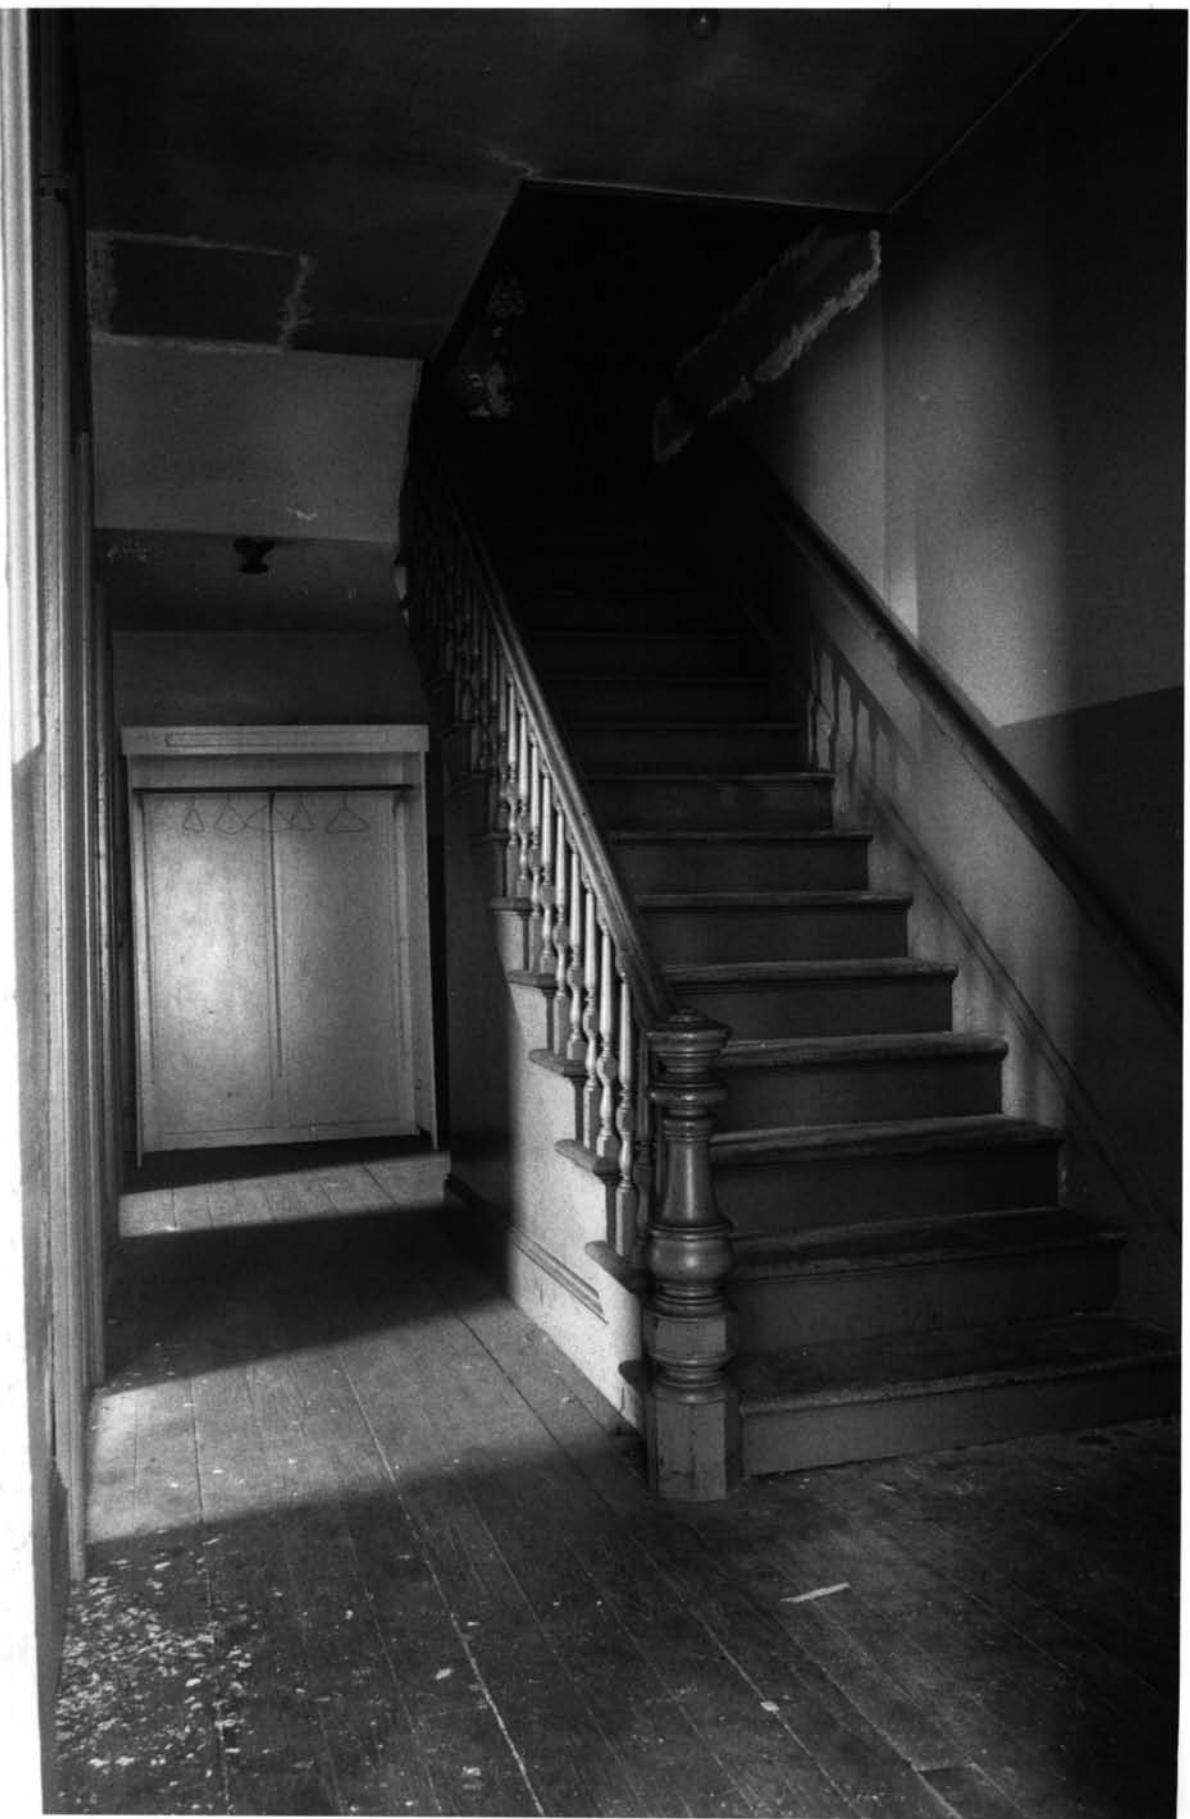
Photo # 6

View: Interior, second floor stair, view west.

The second and third floor plans are nearly identical, with a U-shaped arrangement of rooms on the southeast, southwest, and northwest around a stairhall located in the northeast central area. The original stair connecting the second and third floors is still in place. On the second floor, replacement floors boards indicate where the stair rose under the existing stair from the first floor below. Immediately to the northwest, a portion of the hall party wall between Honan's Block and 112-114 Main Street was removed to join the second floors of the two buildings. The upper floors of Honan's Block are now reached by a first floor stair against the southwest wall of 112-114 Main Street. The rear ell is reached from a door opening near the center of the rear wall.

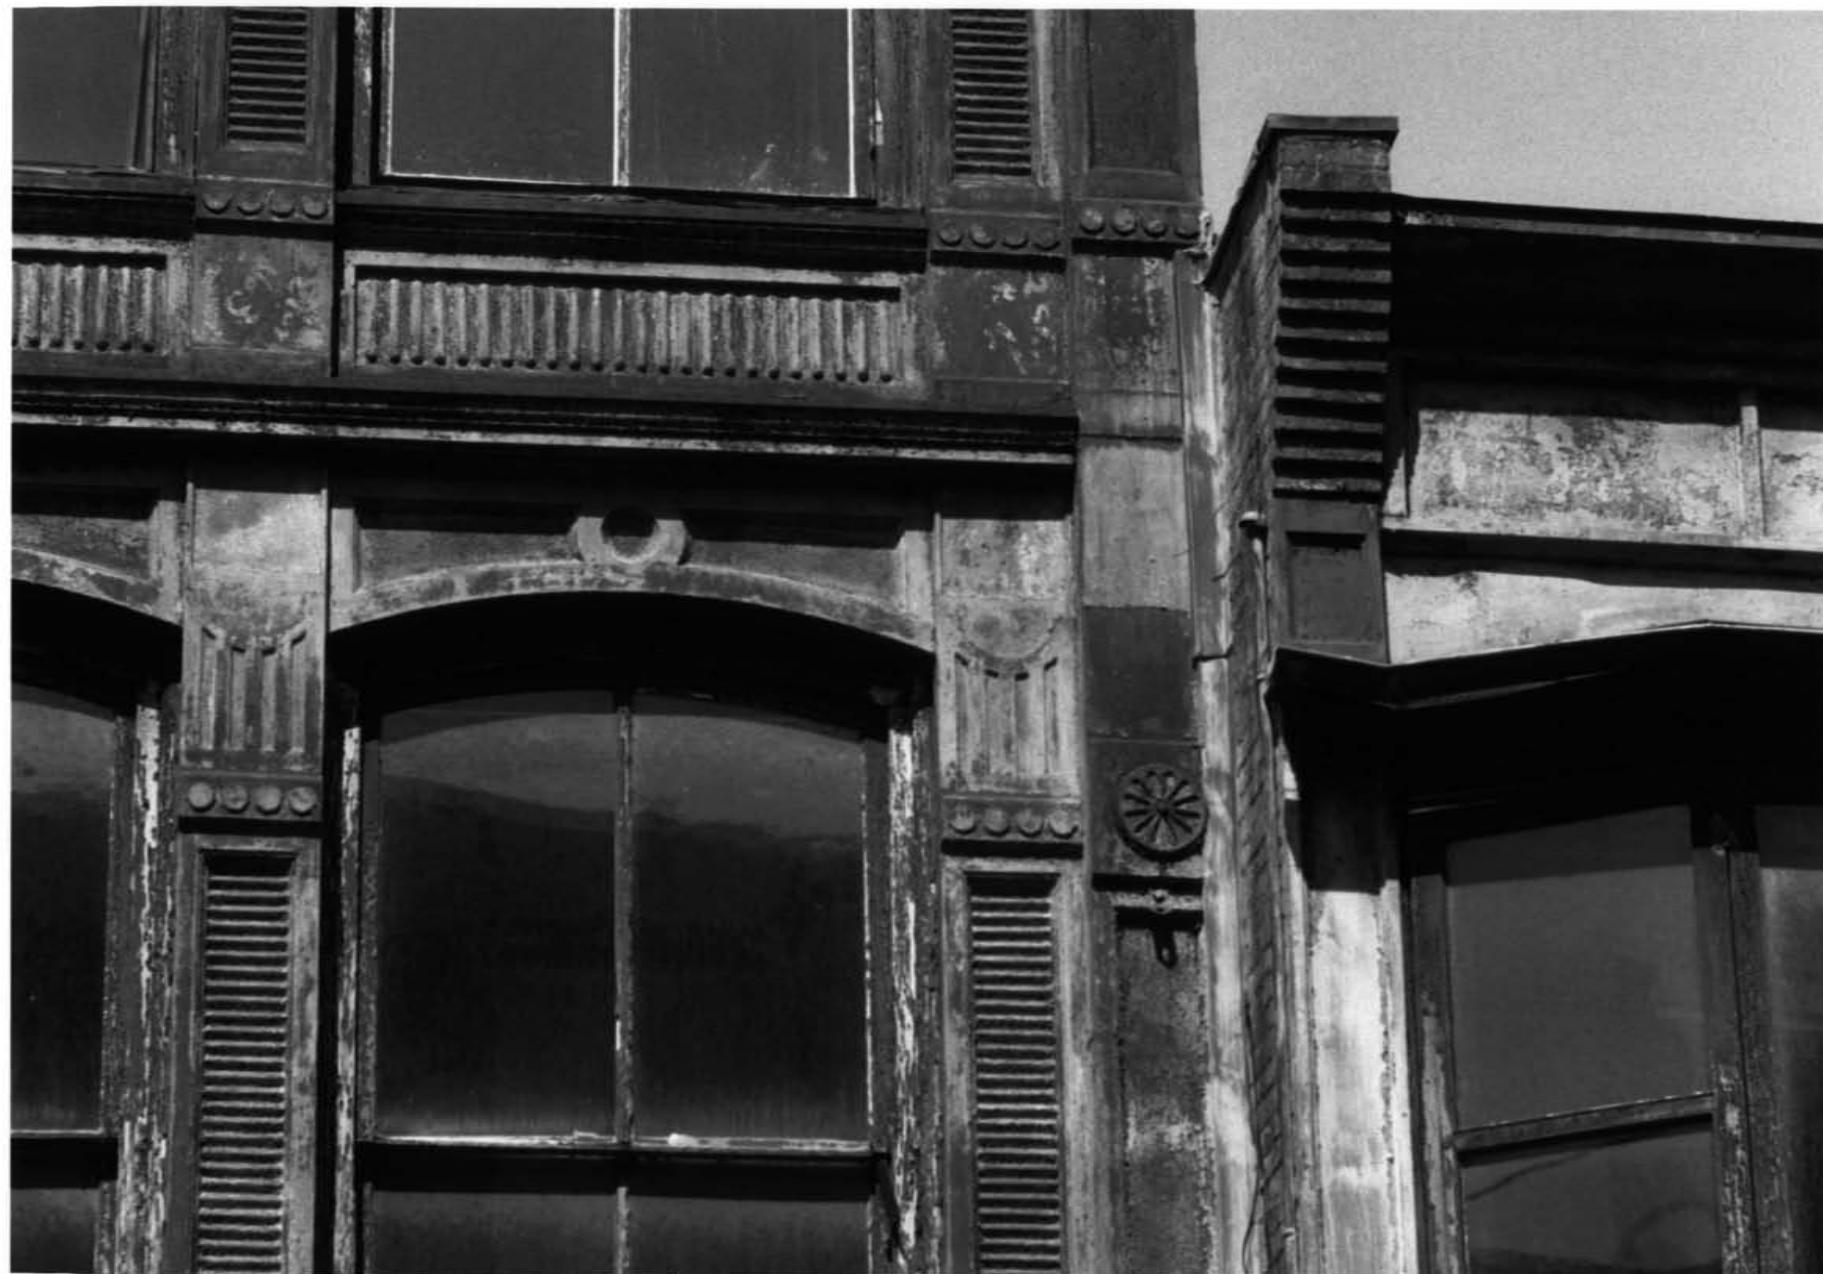
Photo #5

View: Window detail, view west.

Windows throughout Honan's Block are mostly original, with two-over-two, segmental-arched, double-hung windows on the southeast elevation. The rear ell has two-over-one, double-hung, rectangular windows set in segmental openings. The flat roof of the Honan's Block is covered with tar and gravel; a tall, narrow brick chimney rises from the rear of the building's roof.

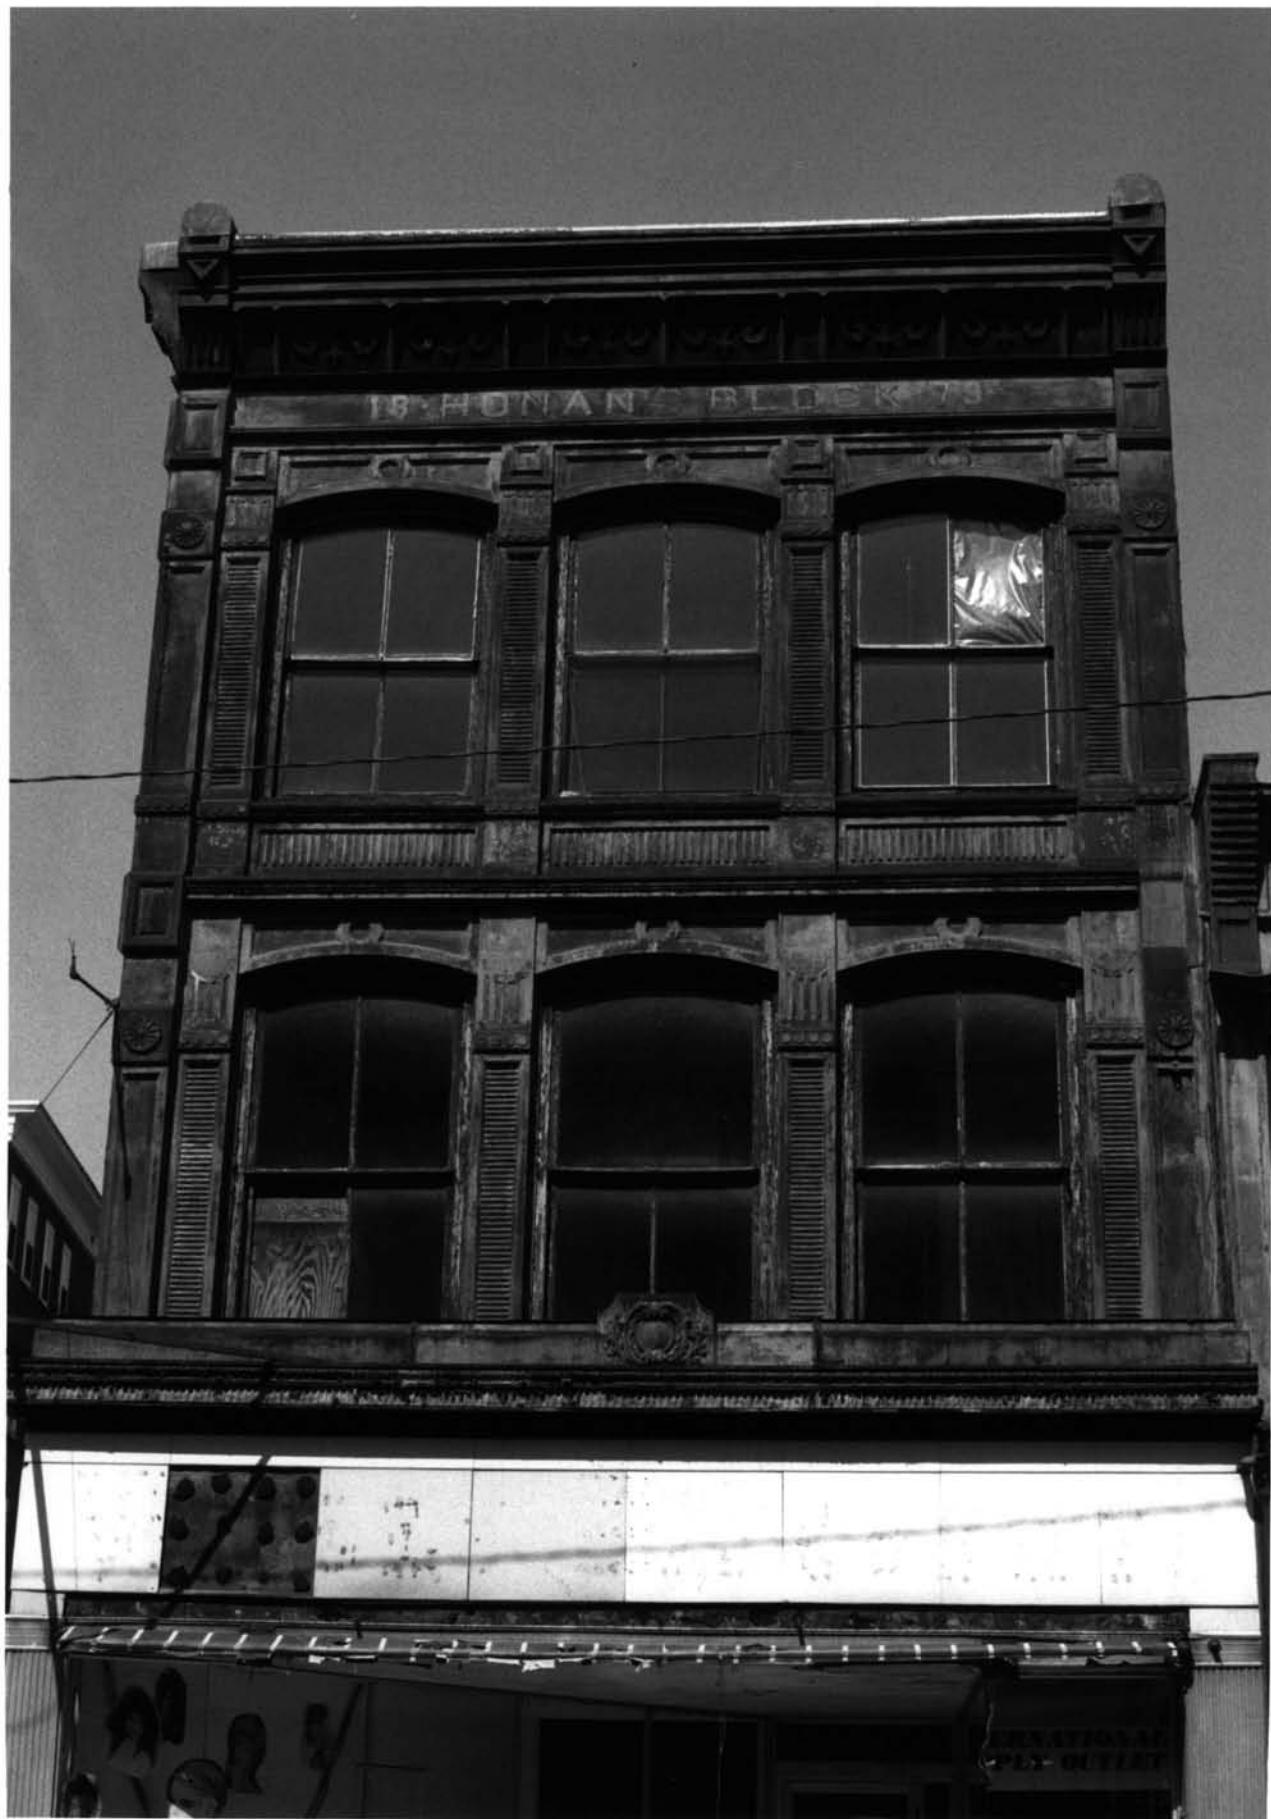
Photo #2

View: Honan's Block Main Street facade,
view west.

facade is pierced by three large, segmental-arched windows on each floor and is richly articulated with a complex pattern of non-structural, trabeated horizontal and vertical elements embellished with paneling, reeding, and circular bosses. At the top, a frieze contains the ghost of lettering which reads "18 HONAN'S BLOCK 79", surmounted by a deep cornice with console brackets at the ends and panels containing stylized floral designs. Although little paint remains on the ironwork, traces of a possibly polychrome paint scheme are still visible.
