National Register of Historic Places Registration Form

historic name: Ballou - Weatherhead House

7. Description

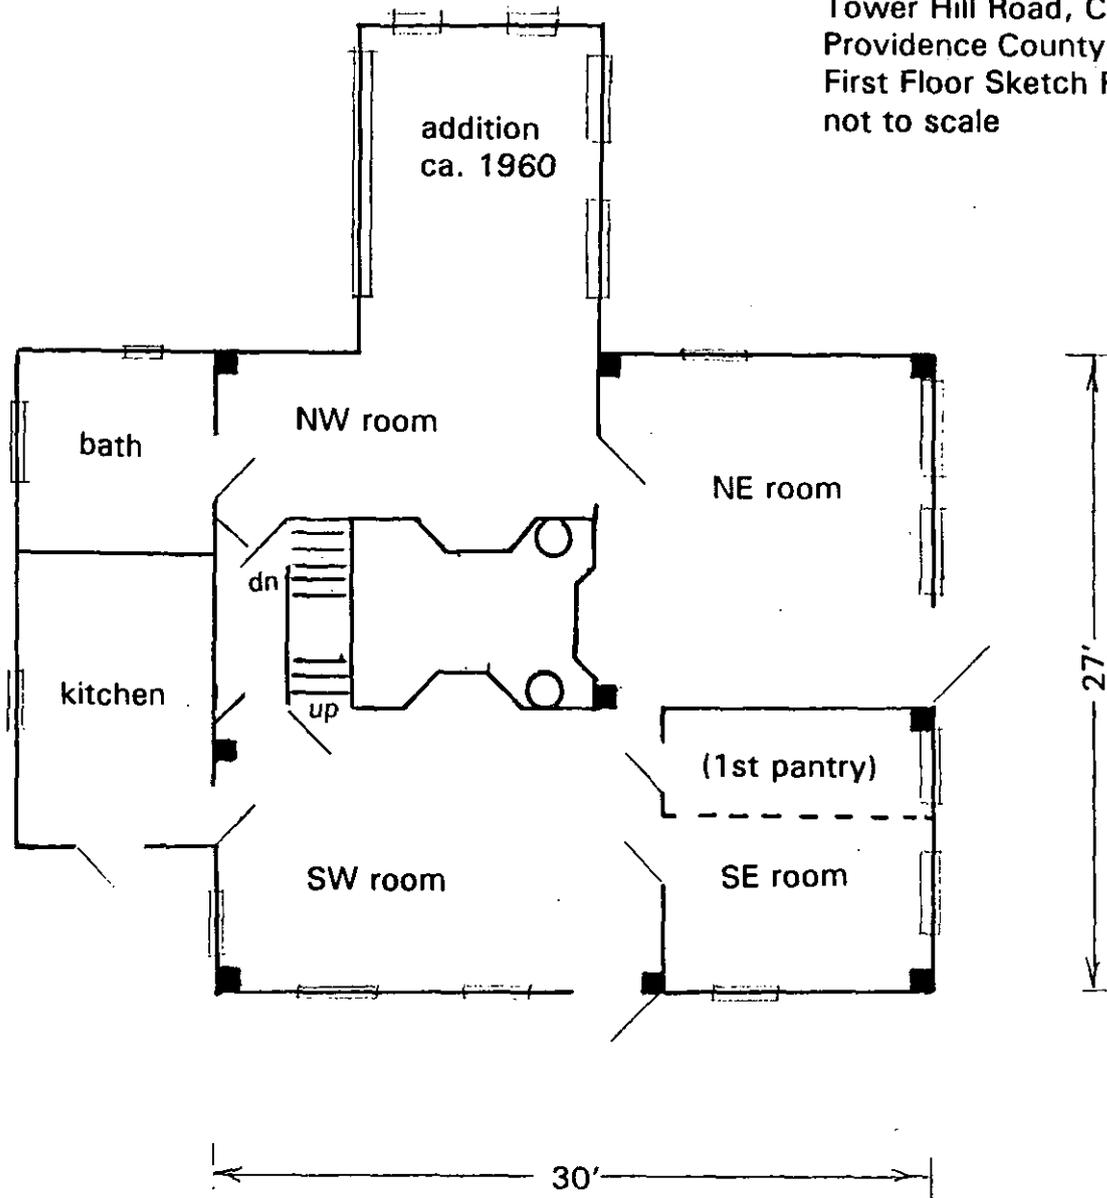
BALLOU - WEATHERHEAD HOUSE
Tower Hill Road, Cumberland
Providence County, Rhode Island
First Floor Sketch Plan
not to scale

The interior first floor plan of the main house consists of four primary rooms. Three rooms are arranged on the south, east, and north sides of the brick chimney, which is offset to the west of center. A fourth room located on the southeast corner of the house was originally two smaller rooms according to the present owner. On the west side of the

chimney, the plan is completed by an enclosed stair case to the second floor and a short corridor connecting the south and north rooms and providing access to the stone cellar stairs.

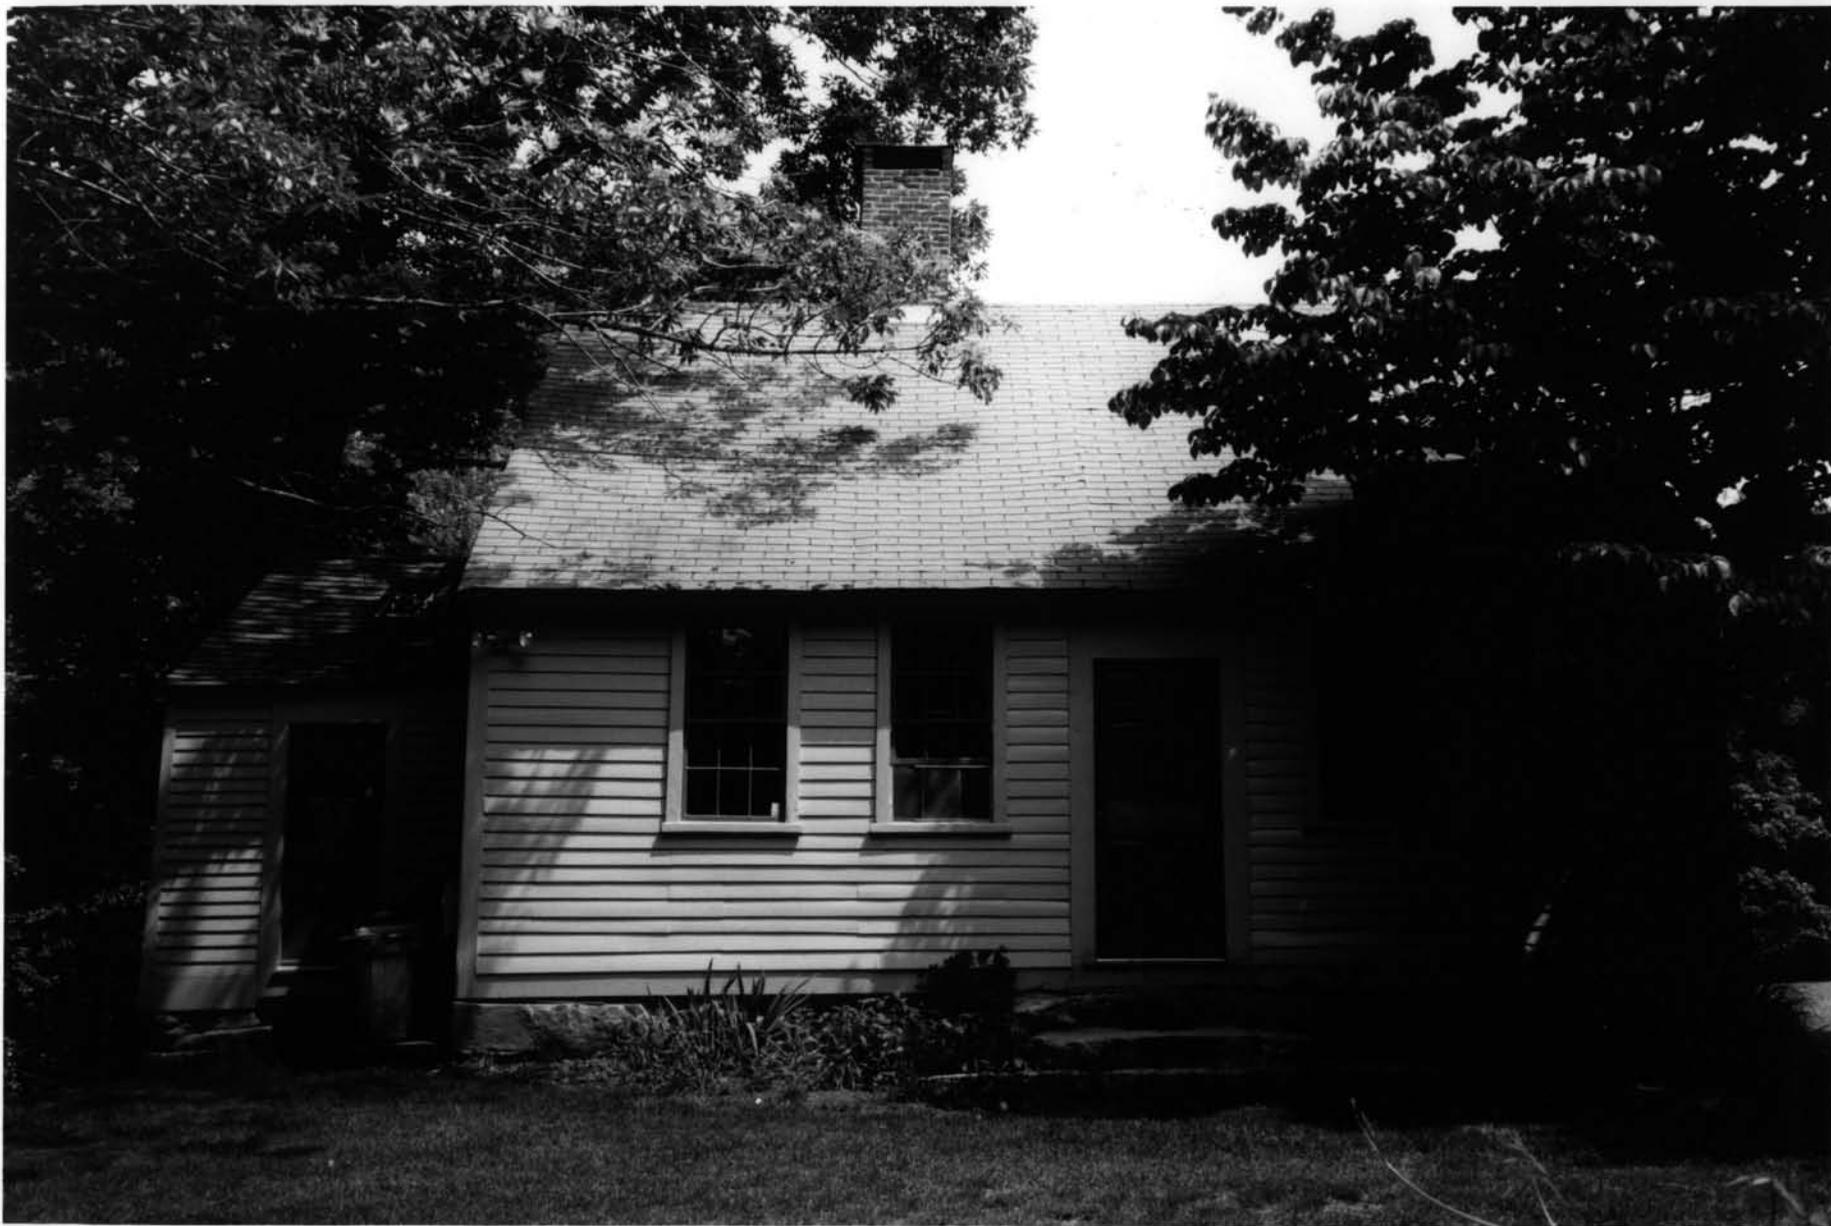
Photo # 1 of 6

1. View looking north at south facade and 19th-century kitchen ell.
2. View looking west at east facade and ca. 1960 ell, with 19-century well head in foreground.
3. View looking north at southwest room fireplace.
4. View looking south at northwest room fireplace.
5. View looking southwest at door, corner post, chair rail, and fireplace of northeast room.
6. View looking southeast from house across enclosed pasture towards entrance drive.

The four-bay south elevation contains what may be the earliest section of the house. The arrangement of openings is irregular, with, from left to right (west to east) two windows, a door, and a window. The five-bay east elevation, contained under the broad end gable, possibly dates from a Federal period expansion. It is composed of five bays on the first floor, with an entrance in the center bay. The actual placement of first floor openings is not quite equally spaced in the wall, being slightly offset to the north. The two attic story windows, however, are centered under the gable peak.

The west and north elevations are partially obscured by additions. The small one-story west ell added in the mid-nineteenth century has a gable roof parallel to that of the main house. It is one-bay wide and is set back towards the rear of the house, leaving the south first floor window and one attic window in the main block. Entrance is through a door in the south end. The north ell, added about 1960, is also one story in height, with a gable roof perpendicular to the main house. It is two bays wide and extends rearward for two bays from the western half of the rear wall of the house. Two windows on both the east and north elevations are six-over-six sash similar to those in the main house. The west elevation, which is the least readily visible, contains plate glass sliding doors. Despite the recent construction date and the use of plate glass in this addition, its noncontributing status is mitigated by its reference to the older house in massing, materials, small scale, and relatively unobtrusive siting.
